SEC. 35 T. 38 N. R. 7 <sup>E</sup> <sub>W</sub>

RECEIVED & FILED **1826**  
 Ocala County Surveyor's Office  
 Date... **APR 22 1988**  
 By *S. J.*  
 OCS Area #.....

SEC: 35 T. 38 N. R. 7 E W.

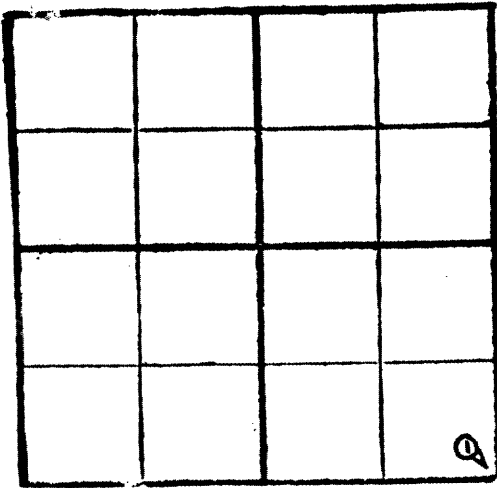
① Found 2" IP. w/ Brass plug, Badly Damaged,  
 Replaced w/ DNR Brass Cap New Bts. OR 7" N35°E 66.75'  
 PN 8" S24°E, 82.25', OR 18" N39°W 73.60'

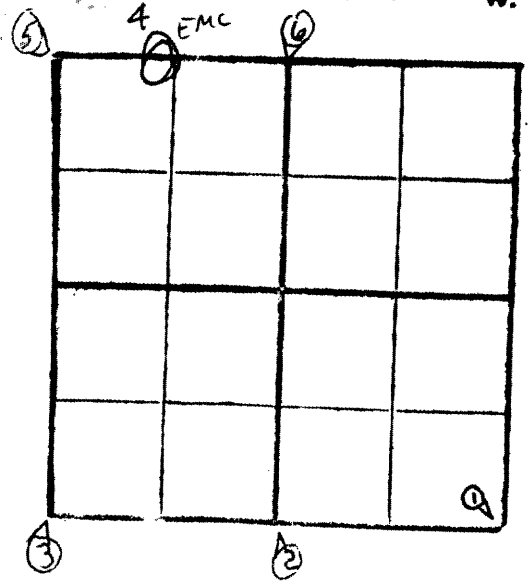
① Found 2" IP. w/ Brass plug, Badly Damaged, Replaced w/ DNR Brass Cap New BTs. OR 7" N 35° E 66.7' PN 8" S 24° E, 82.25', OR 15" N 39° W 73.60'

② 1/4 - 2" i.p. w/ brass plug, map data

③ SW 35 - 2" i.p. w/ brass plug - map data

④ EMC on McNaughton h - found 1 1/2" i.p. w/ WCD b.c. BT<sup>S</sup> PN 24" N 2° E 73.45' Made BT<sup>S</sup> PN 10" N 59° E 15.60' PN 10" S 2° E 6.10' PJ 14" N 85° W 23.14' Corner is 200' S. of boat landing and 40' east of lake shore (Seymour 11/22/88)

⑤ NW 35 - Hal Berndt found orig. BW clump, set WCD b.c. and made BT<sup>S</sup> PW 11" N 18° E 43.23', PW 14" S 76° W 54.25'. This is from B. Woods notes.

⑥ N 1/4 35 - 1" i.p. in swamp, BT<sup>S</sup> SB 7" S 85° E 19.47', SB 8" S 4° W 19.07' (from B. Woods notes)

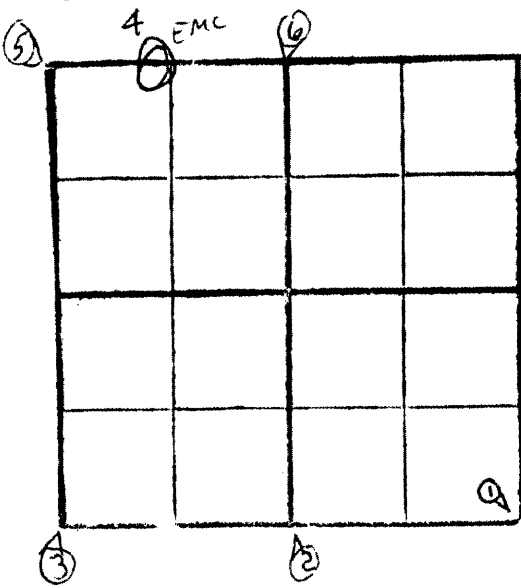
① Found 2" I.P. w/ Brass plug, Badly Damaged,  
 Replaced w/ DNR Brass Cap New BTs. OR 7" N39°E 66.75'  
 PN 8" S24°E, 82.25', OR 13" N39°W 73.60'

② 5/4 - 2" i.p. w/brass plug, map data

③ SW 35 - 2" i.p. w/brass plug - map data

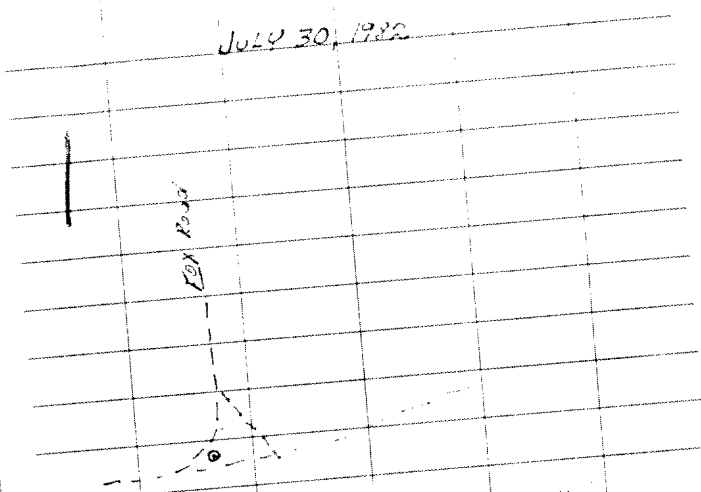
Found 2" I.P. w/ Brass plug Marked  
 For SA Cor 35-38-2  
 Pipe was bent when setting BT  
 Replaced pipe w/ DNR Brass Cap  
 BT 7" N39°E 66.75'  
 PN 8" S24°E 82.25'  
 LP 13" N39°W 73.60'

found 1 1/2" i.p. w/ WCD b.c. BT<sup>s</sup> PN 24" N2°E 73.45'  
 PJ 14" N85°W 23.4'  
 "N59°E 15.60'  
 "S2°E 6.10'

Corner is 200' S. of boat landing and  
 40' east of lake shore  
 (Seymour 11/22/88)
