CERTIFIED LAND CORNER RESTORATION

U.S. PUBLIC LAND SURVEY MONUMENT LOCATION RECORD

USPLS CORNER: NW CORNER SECTION: 19 TOWNSHIP: 36 NORTH RANGE: 9 EAST
 NAME OF WATERWAY FOR M.C. CORNER: N/A SECTION LINE: N/A
 (OFF) (VILLAGE) (TOWN) OF: PELICAN COUNTY OF: ONEIDA

U.S. PUBLIC LAND SURVEY MONUMENT RECORD

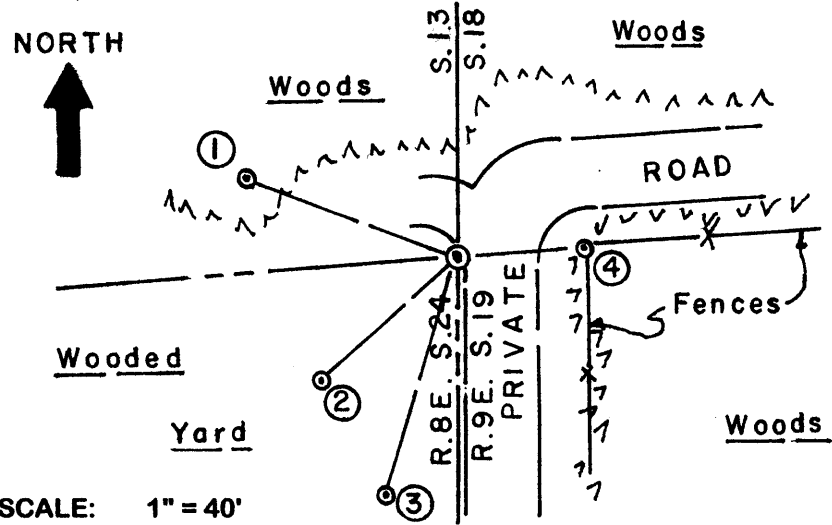
I found uncapped top of record 2" dia. iron pipe flush at this corner but upon excavation to remove for placement of a new monument I found the upper part of old iron pipe bent to the North about 30°, undoubtedly by previous roadway grading or plowing. I carefully removed the old iron pipe which revealed the original plumb soil cavity for the lower part of the pipe below grade, into which I drove a standard 2" dia. by 30" long aluminum pipe monument with stamped Oneida County cap 6" below grade to deter any future disturbance. Corner falls 10" +/- West of North/South center of gravelled private road.

Older 1.5" dia. iron pipe noted to be by Vaughan N86°E 25.57' per Immich found as very loose 2" iron pipe 6" West of old wood corner post for fences East and South, which I redrove to secure 10" above grade for new ties below. PK noted by Immich in West side of power pole N02°E 23.82' was undoubtedly measured to the top of old bent 2" iron pipe as PK now at N07°E 24.56' from new monument set; the pole also appears to be tipped or likely reset since 1982 so reference is considered unreliable. The 4" Spruce BT noted by Immich at S15°W 27.07' is now a 2' high sawed stump. The 4" Spruce noted by Immich N72°W 46.60' found OK and used for new ties below. The NE corner of block foundation noted by Immich S32°W 81.30' is now inaccessible due to large Pr intervening on line thereto. This recovery completed September 22, 2004; there were no direct witnesses.

- WITNESS MONUMENT TIES:**
- ① Older 6.5" Spruce BT with upper blaze shut and lower blaze nearly shut N69°W 46.56'.
 - ② New 9" Spruce BT S47°W 38.28'.
 - ③ New 17" Or BT S17°W 52.36'.
 - ④ Old 2" dia. record iron pipe N86°E 25.76'.
- I set a standard white poly 'T' marker post on SW side of old wood fence corner post East of corner.

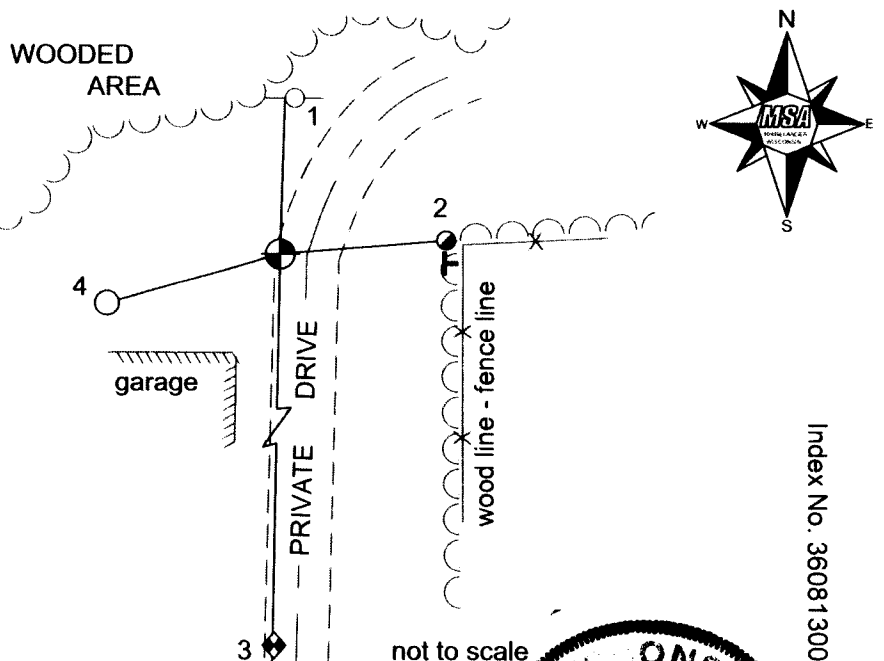
June 29, 2018 - In the process of re-setting the corner for Chad Besaw, I found a 2" diameter Oneida County aluminum monument ±18" below surface grade and accepted it as the corner location and further perpetuated as shown below.

Witness Table			
Point #	Description	Bearing	Distance
1 EX.	FOUND P.K. NAIL IN WEST SIDE OF POWER POLE	N05°E (N02°E)	24.50' (23.82')
2 EX.	FOUND 2" DIA IRON PIPE	N85°E (N86°E)	25.97' (25.76')
3 NEW	FOUND 1-1/4" DIA. IRON PIPE FROM O.C. SURVEY MAP #A2137A	S01°W	138.09' (138.04')
4 NEW	SET 7/8" DIA. X 30" LONG IRON REBAR WITH YELLOW MSA CAP	S74°W	28.16'

If this corner ever needs to be re-established, I have a 2" diameter X 30" long Oneida County Aluminum monument stamped and ready to place.
