CERTIFIED LAND CORNER RESTORATION

**U.S. PUBLIC LAND SURVEY MONUMENT LOCATION RECORD**

USPLS CORNER: NORTH 1/4 SECTION: 24 TOWNSHIP: 36 NORTH RANGE: 8 EAST  
 NAME OF WATERWAY FOR M.C. CORNER : N/A SECTION LINE: N/A  
 (CITY)(VILLAGE)(TOWN) OF: CRESCENT COUNTY OF: ONEIDA

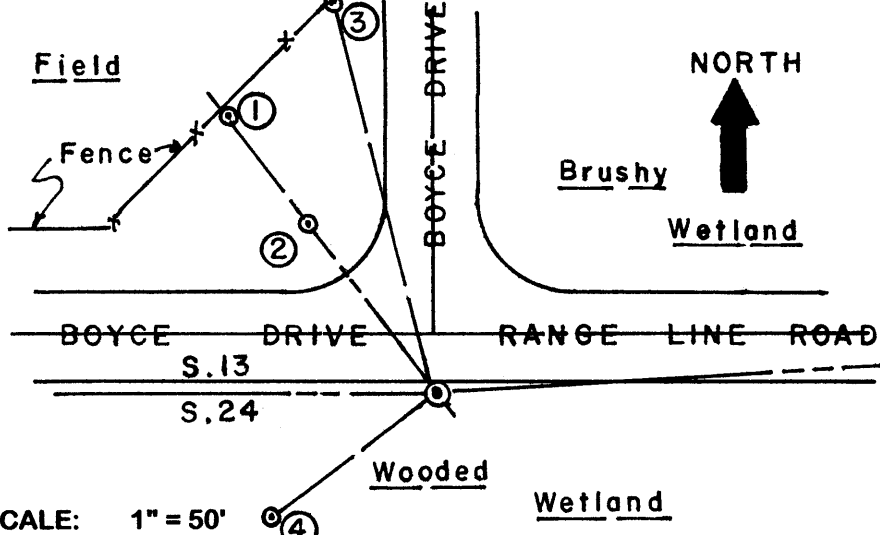
Found and accepted an older 1" dia. iron pipe monument with red poly Permamark cap 4" below grade of South gravelled shoulder and 2.9' South of the South edge of East/West/North blacktop roadways. I left the iron pipe in place and drove a standard 2" dia. by 30" long aluminum pipe monument with stamped Oneida County cap over it to 5" below grade of road shoulder. I could find no evidence of 2" dia. iron pipe at corner per Immich; likely destroyed by roadway work since.

The 1" capped iron pipe 33.00' South per Immich found as a very loose and tipped 1.5" dia. capped iron pipe in boggy wetland, which upon replumbing checked OK to iron pipe found at corner.; PK in East side of power pole S14°W 12.47' per Immich checked OK to iron pipe at corner; 6" Cedar N47°E 149.55' per Immich is inaccessible due to very thick brushy wetland conditions; 7" Alder S45°W 49.05' per Immich found OK with upper blaze shut and lower blaze open; 4" Alder S74°E 54.60' per Immich not found. I did not check for PK in power pole N40°W 156.62' per Immich as such reference is considered unreliable from my previous experience with utility poles at distances beyond a 100' tape length.

- ① 5/8" dia. by 24" long rebar set with yellow poly RM cap 3" up N37°W 90.78' at fence line S40°W/N40°E.
- ② 5/8" dia. by 24" long rebar set with yellow poly RM cap 1" up N37°W 54.93'.
- ③ 5/8" dia. by 24" long rebar set with yellow poly RM cap 1" up N15°W 109.75'; at corner of fences North and S40°W.
- ④ New 12" Alder BT S53°W 53.58'.

Standard white poly 'T' marker post set 46" South of new corner monument.
