CERTIFIED LAND CORNER RESTORATION

Index No. **R9**

U.S. PUBLIC LAND SURVEY MONUMENT RECORD

South East Section Corner 3610200000
Section 20
Township 36 North
Range 10 East
Town of Pelican
County of Oneida

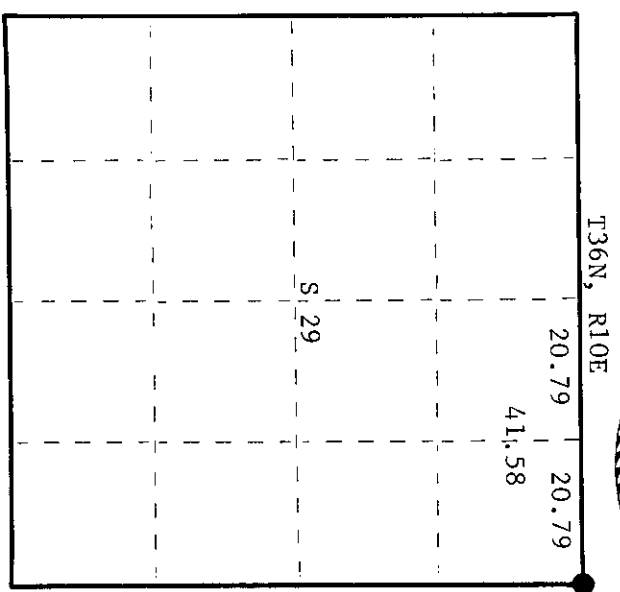
Description of monument and accessories I established to perpetuate the original location of this corner.
Set a 2½" iron pipe with brass cap for a witness corner 60 links North stamped - S498
The iron pipe was left in place at true corner. T36N, R10E
OBT and NBT bearings and measurements are made from true corner.

S20 | S21 WC
S29 | S28
N 60 links
CPI-1975

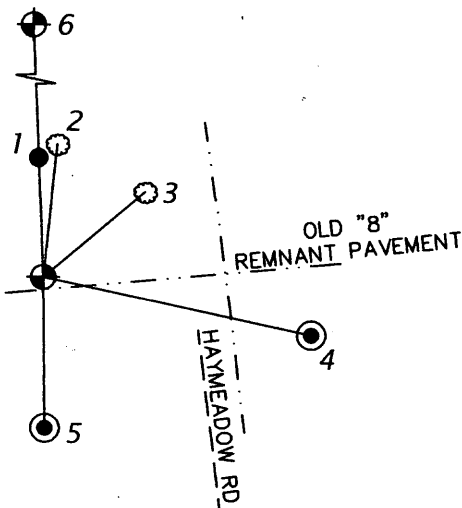
June 30, 2011- Anthony R. Jones found 1" o.d. iron pipe 6" below ground. Found WC south as shown on Hansen tie sheet and added new witness corners as shown below. Did not recover OBT by Dorr N1°W, 30 lks. U.S. Dept. of Interior elevation benchmark has been lost.

- 1: FOUND DOT R.O.W. POST, 31' NORTH
- 2: SET 60D SPIKE IN 15" RED PINE W/CPI SIGN
N 05°41'25" E, 34.71'
- 3: SET 60D SPIKE IN 24" RED PINE W/ BLUE PAINT N 49°51'36" E, 34.58'
(N43 1/2°E, 51.5 lks)
- 4: SET 3/4" BY 18" IRON ROD
- 5: FOUND 2 1/2" IRON ROD WITH BRASS CAP STAMPED AS SHOWN ON HANSEN TIE SHEETS 00°49'51" E, 39.49' (60 lks, SOUTH)
- 6: FOUND 2 1/2" IRON PIPE WITH BRASS CAP MARKING EAST 1/14 CORNER SECTION 20
N 02°34'11" W, 2492.69'

FOUND 1" IRON PIPE AS NOTED BY HANSEN
