CERTIFIED LAND CORNER RESTORATION

Index No. **2-1**

Index No. 21
371036000

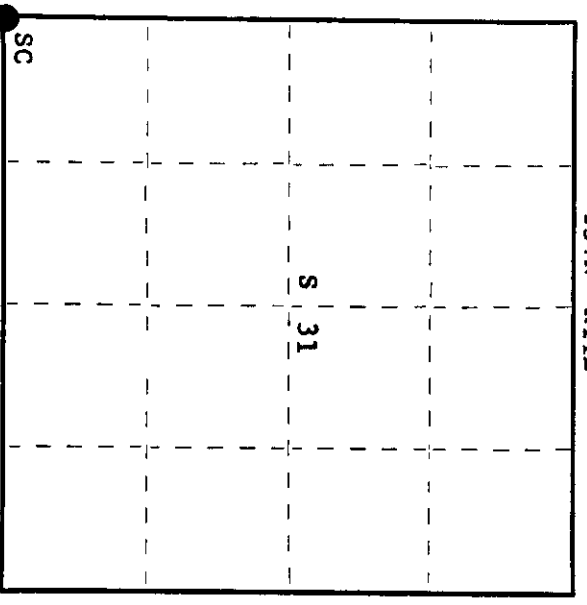
Recovered Maine's 2 1/2" iron pipe with screw on brass cap in poor condition projecting 2 1/2" above ground. Cap stamped:
 Also recovered H.C. Lawrence's 6" squared cedar post, lying under snowy moss, rotted but some scribe marks visible.
 Searched for but unable to recover original pine stump BT's.
 Recovered OBT - black spruce 8" N84°W, 35.7 links, scribed BT, origin unknown.

Iron pipe was very rusty and general condition very poor.

Replaced old pipe with new 2 1/2" Bernussen A-1 federal monument (O.C.), stamped:
 Monument projects 8" above ground.
 Marked NBT's - black spruce 6" S25°W, 31.4 links
 black spruce 9" S66°E, 34.1 links
 black spruce 6" N58°E, 17.9 links
 all scribed SC BT.

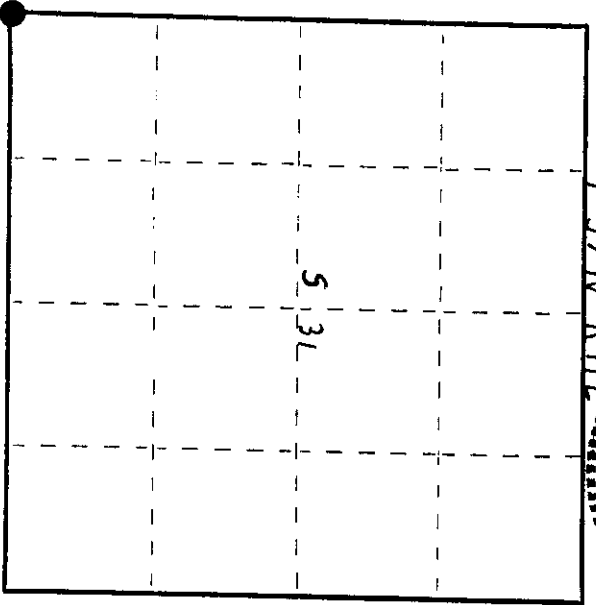
Recovered Hansen's monument bent in half and laying out of the ground. Corner was most likely damaged by logging in the winter in 1984. Also found Lawrence's post.

- Recovered BT's - 8" Black Spruce N84W, 34.7 lks. - 3' stub with lower blaze
- 6" Black Spruce S25W, 31.4 lks. - not found
- 9" Black Spruce S66E, 34.1 lks. - stump with small part of blaze
- 6" Black Spruce N59E, 17.9 lks. - in good condition now 9"

Using the distances from the stumps and one live BT was able to reestablish the corner position. The bearings to the stumps are good, but the bearing to the BT is off by about 20°. Set 2 1/2" aluminum pipe with 3/4" alloy cap from Hansen's monument. The monument is 4" above ground. Set plastic sing post 1' west of monument.

- OBT - 9" (6") Black Spruce N36E(N59E), 12.02'
- NBTs - 10" Tamarack S20E, 66.06'
- 5" Tamarack S79W, 46.20'
- 7" Tamarack N69W, 39.34'
