U.S. PUBLIC LAND SURVEY MONUMENT LOCATION RECORD

USPLS CORNER: NORTH WITNESS MC **SECTION:** 16 **TOWNSHIP:** 36 NORTH **RANGE:** 08 EAST

NAME OF WATERWAY FOR M.C. CORNER : CRESCENT LAKE **SECTION LINE:** WEST

US PUBLIC LAND SURVEY MONUMENT RECORD

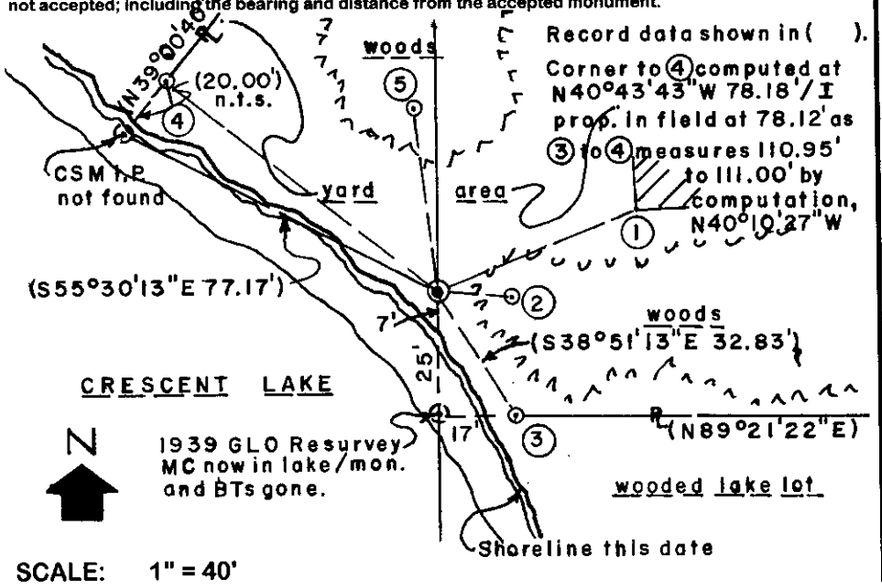
Iron pipe monument set as a Witness MC per Certified Survey Map No. 1312 not found, so I reset the record location by transit/tape resurvey with a standard 2" dia. by 30" long aluminum pipe monument with stamped Oneida County cap 3" above existing lakeshore grade. The 1939 GLO Resurvey concrete monument with brass tablet indicated to be in the lake per CSM No. 1312 is now destroyed as I found two(2) remnants of the 6" dia. concrete post along the existing lake shoreline, which I placed flat on grade next to the new monument set.

Existing shoreline has accreted about 300 feet South of the original GLO MC location which I also recovered previously on May 10, 2000. In September and October 1939, Hal D. Craig and Lester S. Mann/GLO, during their resurvey, set a new MC with a standard 6" dia. by 24" long brass capped concrete monumet on the accreted lake shore S07°19'E 6.26 chains from the foregoing original GLO MC which they also had found and remonumented; their new MC monument now destroyed in lake bed, undoubtedly from lake ice and wave action.

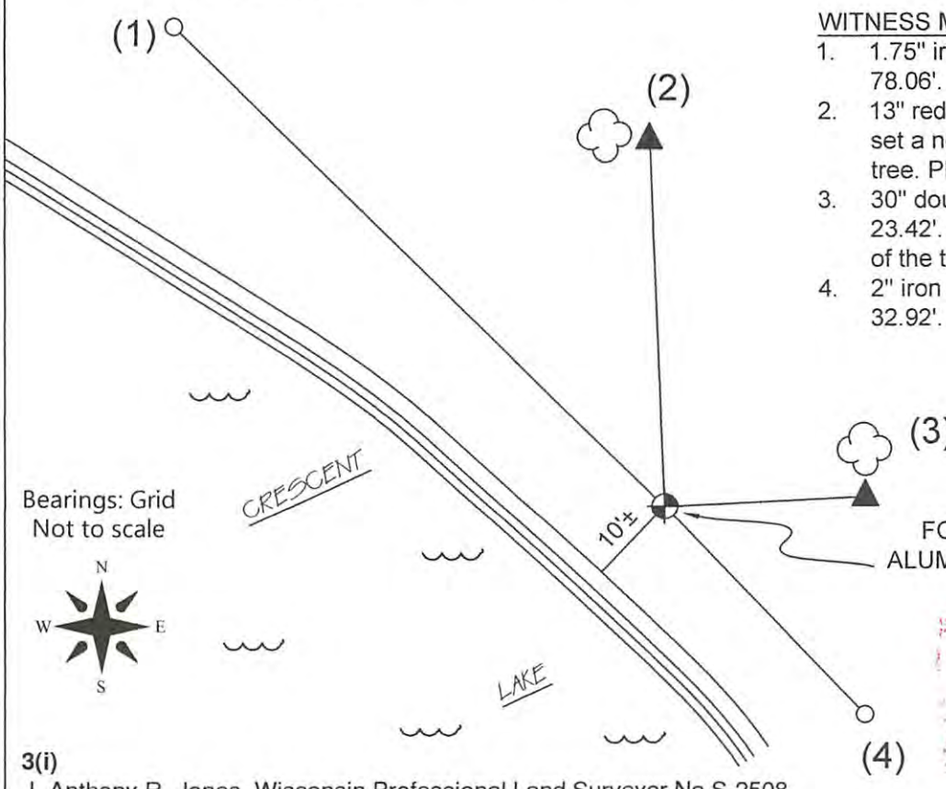
- 9/7/2026 - I, Anthony R. Jones, S-2508, found the stamped Oneida County aluminum monument in good condition as described by Rohde.
  - Rohde's tie to the cabin foundation (1) is no longer valid. The owner told me that the cabin had been rebuilt, so I did not use this tie.

- Rohde's tie to the 12 red pine (2) in no longer valid. I found the stub of the tree uprooted and on the ground, but the PK nail/washers are evident.

- I found the iron pipe (3) in good condition and is shown below. Rohde calls for a 1.5" iron pipe, but I measured 2". I found a white guard post 2' west of this pipe. I did not move the post as the aluminum monument is in a manicured lawn.

- I found the iron pipe (4) in good condition and is shown below. Rohde calls for a 1.25" iron pipe, but I measured 1.75"
  - I found the red pine (5) in good condition and is shown below. PK nail/washers are in place.

- Crescent Lake was shallow, so I did look for the corner in the water as shown by Loftus and Rohde, but no monument was evident.
