SEC. 35 T. 38 N. R. 7 <sup>E</sup> <sub>W</sub>

RECEIVED & FILED **1826**  
 Ocala County Surveyor's Office  
 Date... **APR 22 1988**  
 By *S. J.*  
 OCS Area #.....

SEC: 35 T. 38 N. R. 7 E W.

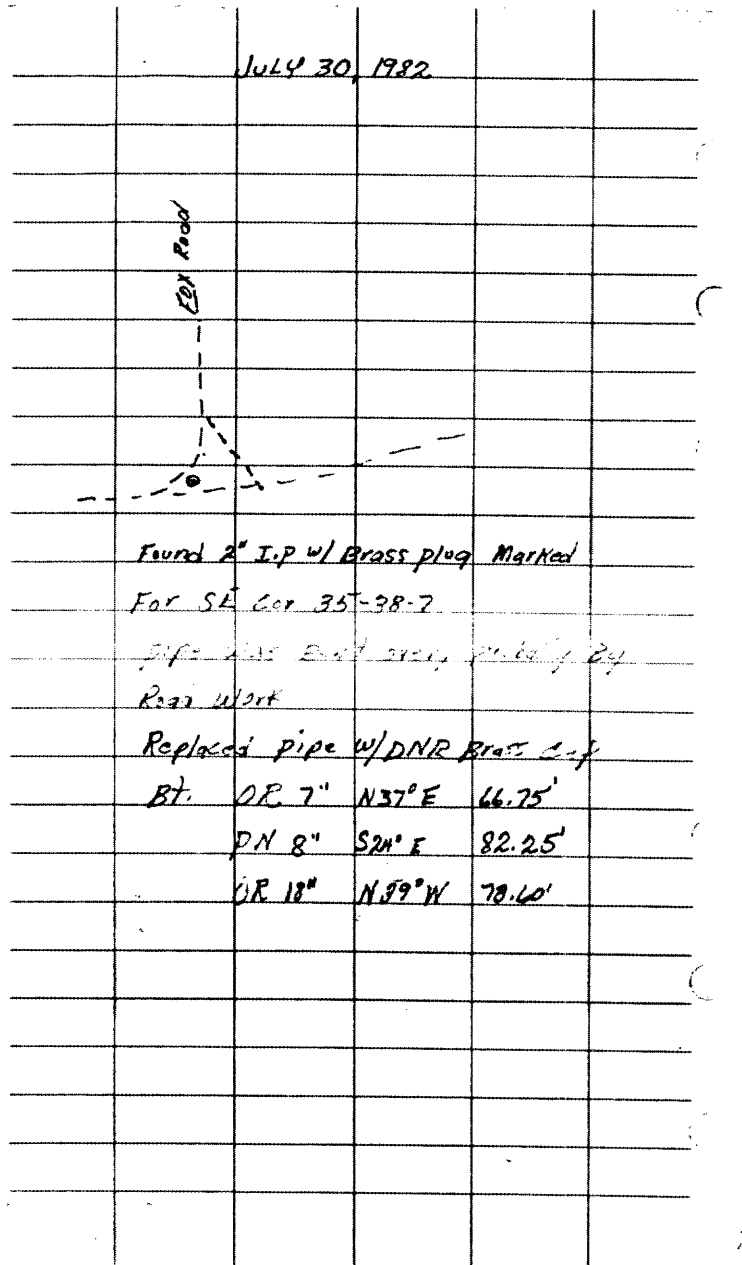
① Found 2" IP. w/ Brass plug, Badly Damaged,  
 Replaced w/ DNR Brass Cap New Bts. OR 7" N35°E 66.75'  
 PN 8" S24°E, 82.25', OR 18" N39°W 73.60'
