U. S. PUBLIC LAND SURVEY MONUMENT RECORD

- (a) Identify the corner by reference to the U.S. public land survey system.
**SE. COR. SECTION 20,
 TOWNSHIP 36 NORTH,
 RANGE 8 EAST,
 ONEIDA COUNTY, WIS.**

Southeast corner of Section 20
Township 36 North
Range 8 East
Town of Crescent
County of Oneida
Wisconsin

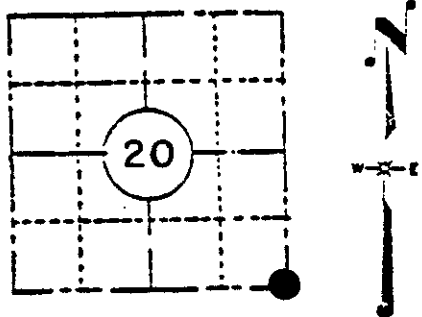
LOCATION SKETCH
 (Location of landmark indicated by '●')

- July 15, 1863 orig. cor. set by W.D. Daugherty 80.00ch from S.E. cor. 29 L.T.s Aspen 15 N 78 E 321k Aspen 6 S 71 W 418
- 1890 E.F. Dorr at corner made new L.T.s pine stump 7 N 2 E 25, pine stump 10 S 16 W 253/4, went north and set 1/2 cor at 27.32ch.

- 1914 D.H. Vaughan at corner and run west to 1/2 cor. 7.33ch; also north to 1/2 cor. 11.41ch.
- 1939 U.S. General Land Office executed a resurvey of the area states in their notes; at S.E. cor, Sec 2152.61 ch. M.C. on west side of Lake Emma ... 53.50 leave marsh... 53.30 fence to the south, 78.62 the point for the cor of secs. 20,21,28&29 which is marked by an iron pin, 1" in dia. at the corner of fences D., W., & S. said by John Hacker and adjoining land owner to be recognized cor. for these sections. Set a concrete monument with brass cap in the ground. No accessories available for witnesses.....thence N 16° 49' W bet. sec. 20&21 3.70 creek; 9.90 N.E. cor. Hackers house bears west 47lks.; 11.60 int. barn; 27.47 1/2 corner. Also from the S. E. cor. sec. 20 S 39° 41' W 2.82 creek; 6.68 fence N & S; 19.50 end of fence along road; 19.85 a graded road; 39.54 1/2 cor.

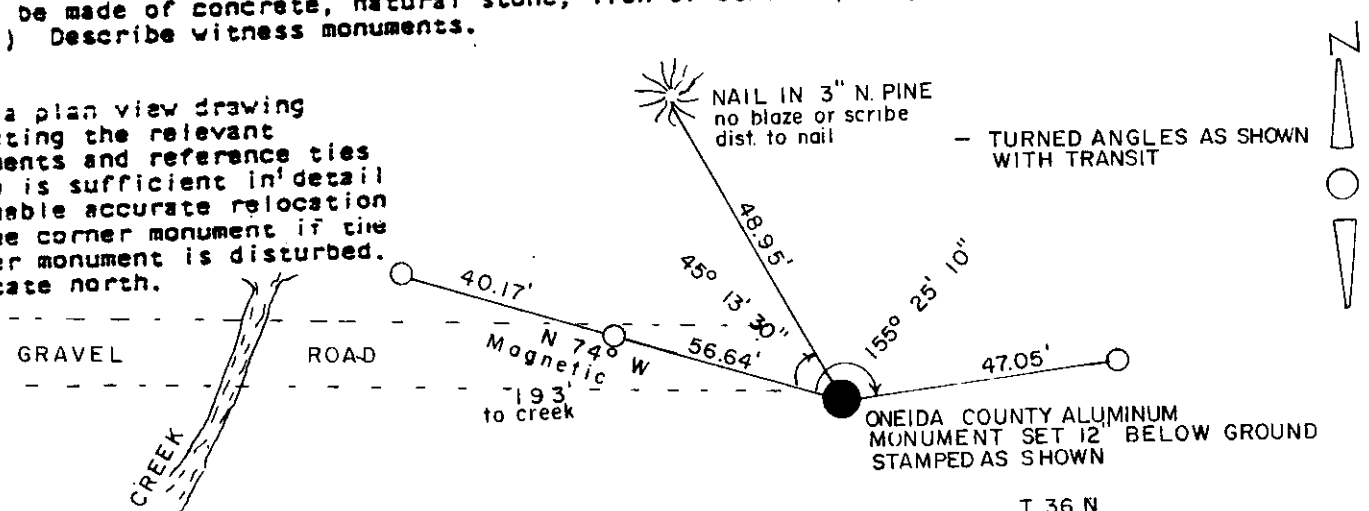
- (d) Show a plan view drawing depicting the relevant monuments and reference ties which is sufficient in detail to enable accurate relocation of the corner monument if the corner monument is disturbed. Indicate north.

T 36 N
 R 8 E
 S 20 | S 21
 S 29 | S 28
 1983

○ SET 1" x 24" IRON PIPE FLUSH

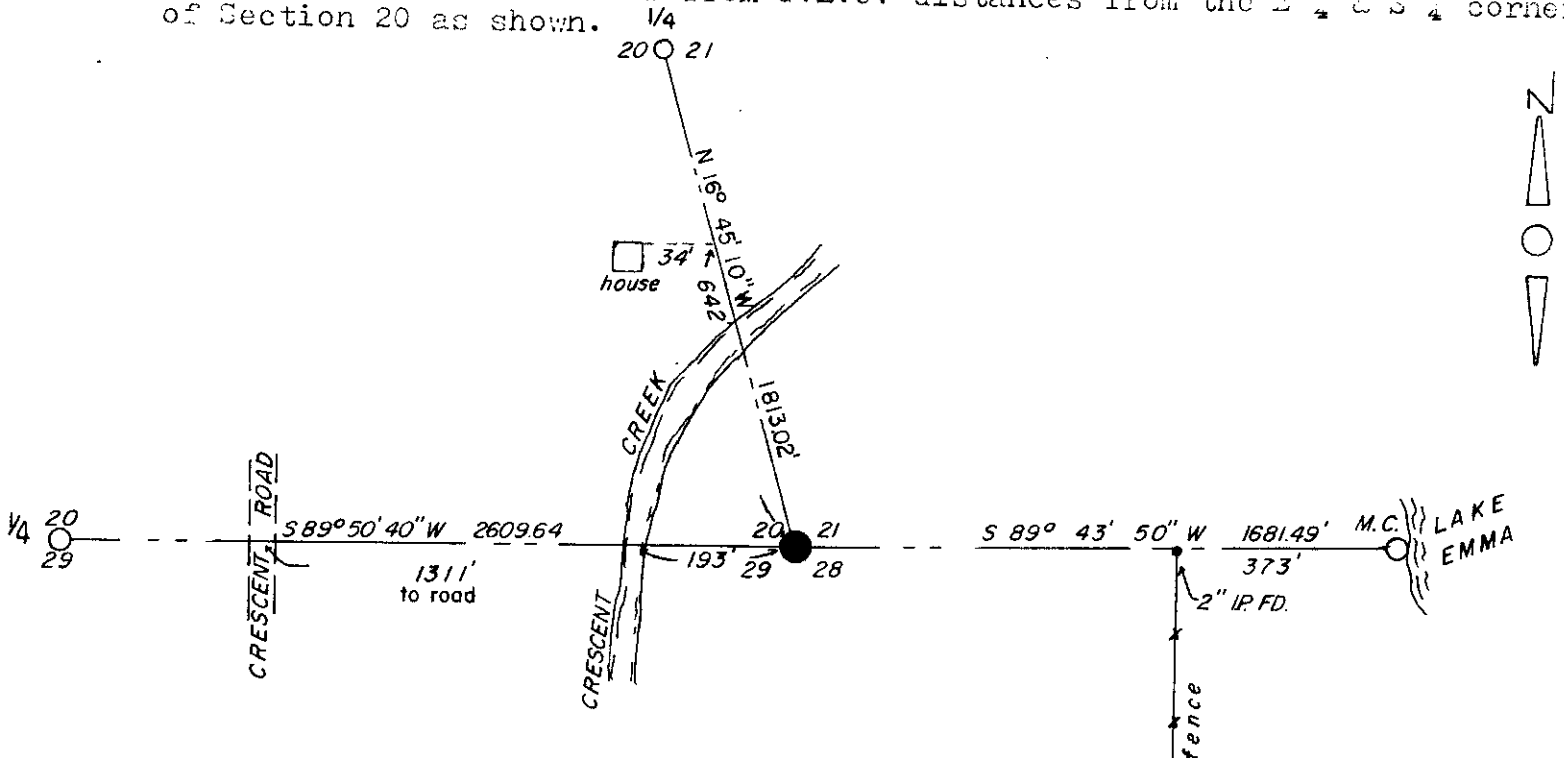
In reestablishing this corner I found a error in U.L.C. measurement to the M.C. on the west shore of Lake Emma. U.L.C. had a distance of 1716.66' versus mine of 1681.49', shorter by 35.17'. I determined that the error was in that distance due to the calls by U.L.C. of Hackers house, the creek and the road call west as shown in the sketch below. It appears the U.L.C. had a 1/2 chain error.

I reestablished the corner from U.L.C. distances from the E 1/4 & S 1/4 corners of Section 20 as shown.

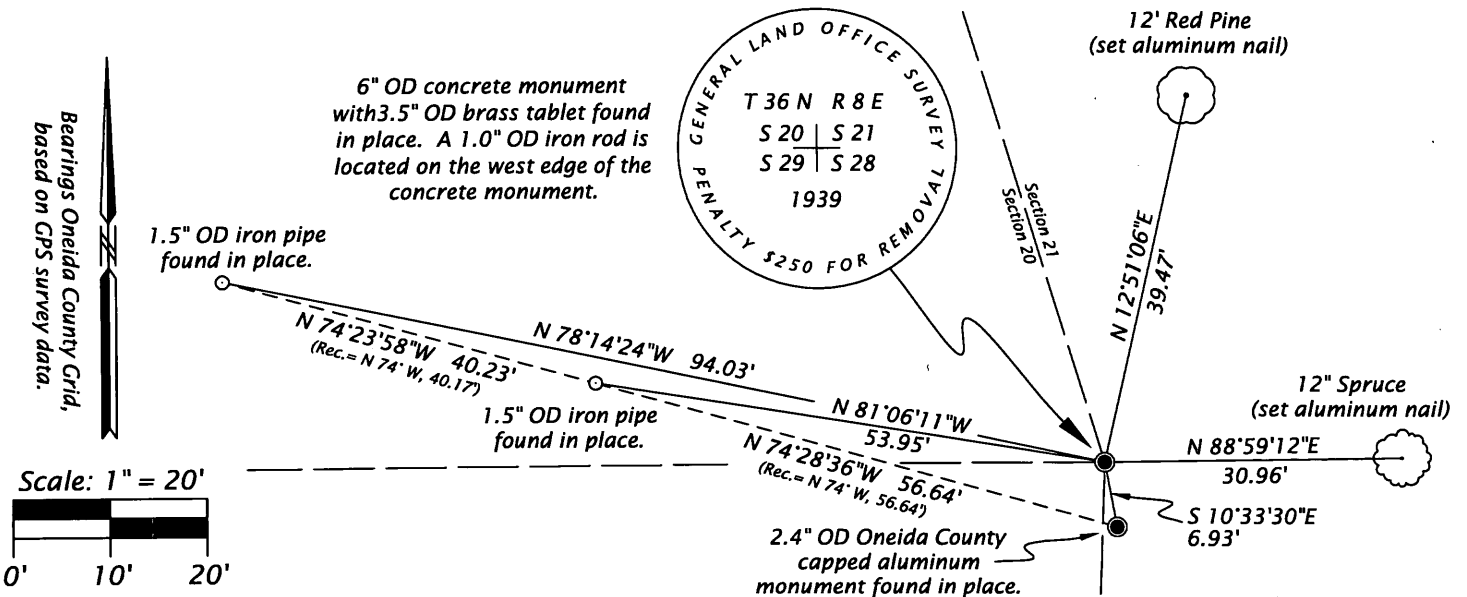
02/22/2011 - I, James D. Rein, Registered Land Surveyor No. S-1234, found a 6" OD concrete monument with 3.5" OD G.L.O. brass tablet in place, and also found Romportl's 2.4" dia. Oneida County aluminum capped monument in place. I accepted the G.L.O. concrete monument as that placed in 1939, however, I also believe there was a 1/2 chain error in the 1939 G.L.O. resurvey from the Meander Corner to the east of here, that M.C. lying on the westerly shore of Emma Lake. I made two (2) new bearing trees and referenced to two (2) existing iron pipe from the 1983 U.S.P.L.S.M.R., as shown in sketch below.

(c)(d)(e) PLAN VIEW OF CORNER WITH TIES TO AT LEAST 4 WITNESS MONUMENTS. IF IN DISAGREEMENT WITH PREVIOUSLY ESTABLISHED CORNER, SHOW THE DISTANCE BETWEEN THE TWO CORNERS AND ALSO INDICATE THE TIES TO THE DISPUTED CORNER.
