**U.S. PUBLIC LAND SURVEY MONUMENT RECORD**

West 1/4 corner of Sec. 33  
Township 38 North  
Range 8 East  
Town of Newbold  
County of Oneida

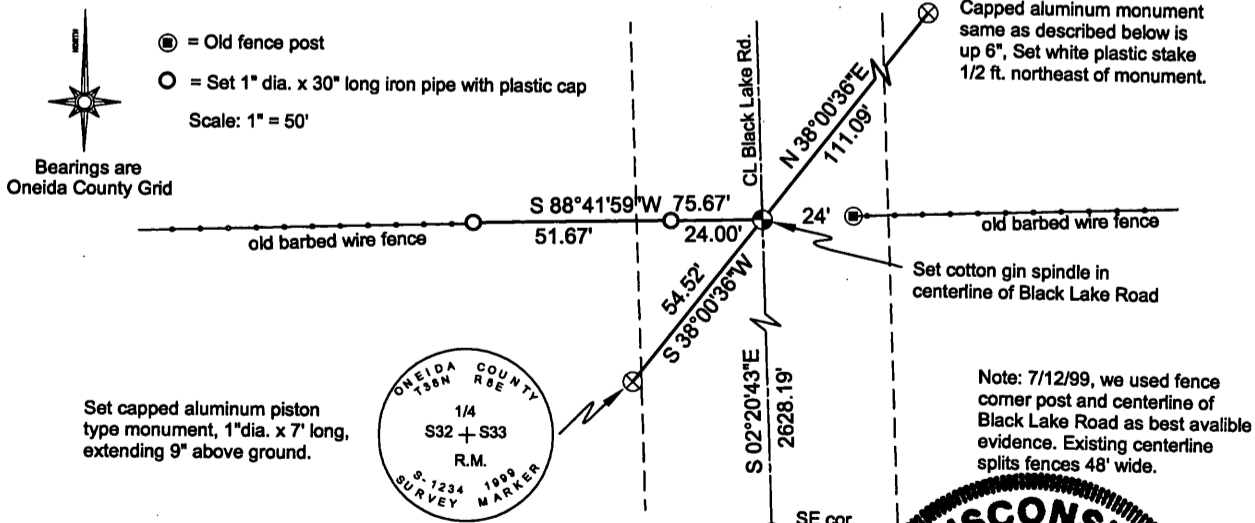
July 7, 1999 - James D. Rein, R.L.S. #1234, unable to find any monument at the corner position. I re-establish the corner at an intersection of the road centerline with old East and West fence lines. This position splits old corner fence posts that are 48 feet apart. Our measured distance of 2628.19 feet between this corner and the southwest section corner compares to Vaughn's 2628.78 feet record. We set a cotton gin spindle and make new reference ties as shown below in the plan.

(c)(d)(e) PLAN VIEW OF CORNER WITH TIES TO AT LEAST 4 WITNESS MONUMENTS. IF IN DISAGREEMENT WITH PREVIOUSLY ESTABLISHED CORNER, SHOW THE DISTANCE BETWEEN THE TWO CORNERS AND ALSO INDICATE THE TIES TO THE DISPUTED CORNER.
