SEC. 14 T. 39 N. R. 9 E W.

SEC. 14 T. 39 N. R. 7 E.

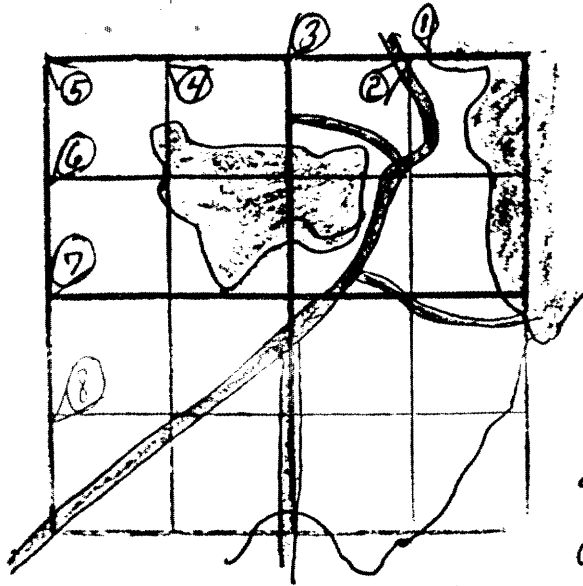
① ~~N 1/4 NE 1/4~~ Member Cor. North side NW 1/4 of section

at 67.89 east of NW Cor fell 3.35 north
of M.C. New B.T. Tam. 14" - S 29° E - 11.2L;
PW 18" - N 41° W - 0.275 ch. (Vaughn 5/19/12)
at 63.223 east of NW Cor replaced old wood
post with ^{W.C.D.} DNR post. Remains of NW O.B.T. BT
found PW (stb.) 15" - S 49° E - 0.263 ch. (~~found~~)
~~although~~; PW (stb.) 15" - S 23° W -
0.604 ch., both by Genest Crq. (Jlg 1972)

② N 1/4 NE 1/4 at 20.551 put in a 2" IP on a pole in spruce swamp
1.592 west of M.C. New B.T. PW 12" - S 42° W - 0.607 ch.; PW 15" -
N 51° W - 0.120 ch. A 2" capped IP bears S 78° W - 0.815 ch. (Jlg 72)

③ N 1/4 Sec 14 Ground overrun of 5.46 & set proportional 1/4 Cor. at 43.50
east of NW Cor. PW (stb.) 28" - N 88° E - 0.845 ch. (Vaughn 5/19/12)
at 41.080 east of NW Cor & 41.102 west of NE Cor. (~~found~~) Ground corner
perpetrated by Walsh Yarnis used by Fisher & Wincertsen. Replaced a capped wood
post with DNR post. Walsh's old B.T. stb 18" ~~at~~ eastly from corner very rotten.
New B.T. PN 15" - N 86° E - 0.764 ch.; PN 12" - S 59° E - 0.430 ch.; PN 18" - S 22° E
0.635 ch. (Jlg 1972)

④ N¹/₄ NW¹/₄ at 21.75 east of NW cor. set '8. PW (sup) 20"
60°E-13; PW (sup.) 24"- 13°E - 0.115 ch (Vaughn 5/19/17)
at 20.540 put our pipe by a yellow 3/4" I.P. by Jennings. OR 12"-
S 26°E - - 0.361 ch; OR 14"- S 75°W - 0.325 ch. (Jlg 1972)

⑤ NW cor. Sec. 14 set the section corner 5.39 (orig. distance) south
of the hole & on the orig line. PW 8" S 70°E - 38 ch; Oak 7" S 30°E -
0.355 ch (Vaughn 5/19/17) Vaughn's PW 8" now 22" - S ^{85°}~~55°~~E - 0.380 ch - ;
Yes Oak 7" is S 36°E ^{0.275 ch +} is broken off. Other B.T. present are PW 14" - N 35°E -
1.718 ch; PW 18" - N 81°E - 0.293 ch. New B.T. PN 18" - S 24°E - 0.633 ch.
Dug 1 foot of earth off of large flat rock & chiseled X for cor corner on it.
Angled steel sign post over X of corner. (Jlg 1972)

⑥ W¹/₄ NW¹/₄ at 20.764

① W¹/₄ Sec 14 a w.c.d. ~~file~~ at 41.528 each way (Jly 1946)

② W¹/₄ SW¹/₄ at 20.764

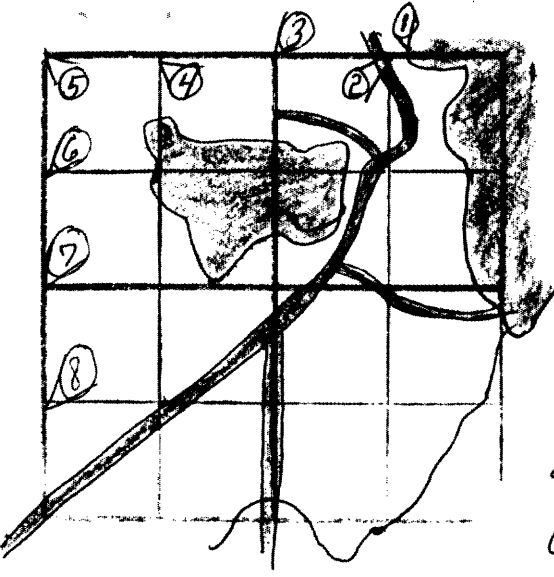
① ~~At 67.89~~ Member Cor. North Line - West of Pattern
 at 67.89 east of NW Cor fell 3.35 north
 of M.C. New B.T. $Tham. 14'' - S 29^\circ E - 11.11$;
 $PW 18'' - N 41^\circ W - 0.275 ch$ (Vaughn 5/19/17)
 at 63.223 east of NW cor replaced old wood
 post with ^{W.C.D.} DNR. ~~post~~. Remains of NW O.B.T. BT
 $Present PW (stp.) 15'' - S 49^\circ E - 0.263 ch$ (~~Post by Vaughn~~)
~~at 63.223 east of NW cor replaced old wood~~
 $0.604 ch.$, both by Geneset Eng. (Jlg 1972)

② N 1/4 NE 1/4 at 20.551 put in a 2" IP on a pole in spruce swamp
 1.592 west of M.C. New B.T. $PW 12'' - S 42^\circ W - 0.607 ch.$; $PW 15'' -$
 $N 51^\circ W - 0.120 ch.$ a 2" capped IP bears $S 78^\circ W - 0.815 ch.$ (Jlg 72)

③ N 1/4 Sec 14 Ground overrun of 5.46 & set proportional 1/4 Cor. at 43.50
 east of NW Cor. $PW (stp.) 28'' - N 88^\circ E - 0.845 ch.$ (Vaughn 5/19/17)
 at 41.080 east of NW Cor & 41.102 west of NE Cor. (~~Post by Vaughn~~) Ground corner
 perpetuated by Walsh & Sons used by Fisher & Wincertsen. Replaced a capped well
 post with DNR. ~~post~~. Walsh's old B.T. $stp 18''$ ~~at~~ east of corner very rotten.
 New B.T. $PN 15'' - N 86^\circ E - 0.764 ch.$; $PN 12'' - S 59^\circ E - 0.430 ch.$; $PN 18'' - S 22^\circ E -$
 $0.635 ch.$ (Jlg 1972)

⑤ NW cor. Sec. 14 Set the section corner 5.39 (orig. distance) south
of the hole & on the orig line. PW 8" S 70°E - 38 ch; Oak 7" S 30°E -
0.355 ch (Vaughn 5/19/17) Vaughn's PW 8" now 22" - S ^{85°}~~80°~~E - 0.380 ch - ;
"Yes Oak 7" is S 36°E ^{0.275 ch +} is broken off. Other B.T. present are PW 14" N 35°E -
1.718 ch; PW 18" N 81°E - 0.293 ch. New B.T. PN 18" - S 24°E - 0.633 ch.
Dug 1 foot of earth off of large flat rock & chiseled X for cor corner on it.
Angled steel sign post over X of corner. (Jlg 1972)

⑥ W¹/₄ NW¹/₄ at 20.764

⑦ W¹/₄ Sec 14 a u.c.d. pipe at 41.528 each way (Jlg 1946)

⑧ W¹/₄ SW¹/₄ at 20.764 Found 2" W.C.D. Brass Cap Made New BTs, MS 6" N62°E
7.74', MS. 12" N81°W 14.75' (Visser, 3/15/95)
