SEC. 2 T. 39 N. R. 7 W.

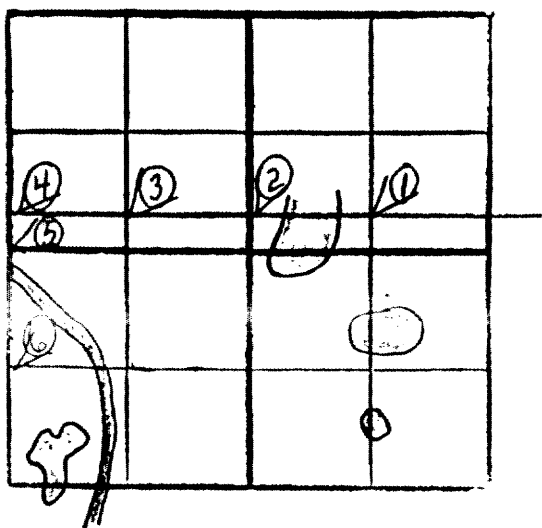
① N<sup>1</sup>/<sub>4</sub> NE<sup>1</sup>/<sub>4</sub> at 20.0435 set 3/4" iron pipe for 1/8 cor. on east edge of open marsh with high hill to east. Pin (copp.) 1/4" S 45° E - 0.446 ch. (Copp & Brunner 4/2/59)

② N<sup>1</sup>/<sub>4</sub> Sec 2 at 79.00 south of N<sup>1</sup>/<sub>4</sub> Sec 35-40-7 fell 5 1/2 ch west of 1/4 cor. OBT. BW 10" - N 16° E - 20 ch. New B.T. BW 12" - N 41° E - 12 ch (Vaughn 12/29/1900). No sign of OBT. or Vaughn's B.T. Set W.C.D. pipe for new 1/4 cor at 40.087. New B.T. Oak 8" - N 69° W - 0.403 ch.; PW 14" - N 82° E - 0.818 ch. (Copp & Brunner 4/2/59) See corner file

③ N<sup>1</sup>/<sub>4</sub> NW<sup>1</sup>/<sub>4</sub> at 20.043 set 1/2" iron pipe for 1/8 cor. New B.T. PN 7" - N 83° W - 0.588 ch. (Copp & Brunner 4/2/59)  
 Sound ip. 12-16-50 Seymour

DNW Cor. Sec 2 Howard R.R. iron in correct place & returns  
 73 PW O.B.T. Replaced iron with W.C.D. pipe. BT position - MH 5"  
 S 43° E - 0.570 ch.; MH 6" - S 31° W - 0.355 ch.; New BT. BW 6" - N 72° W -  
 0.363 ch. (Copp & Bruner 11/10/60)  
 See corner file

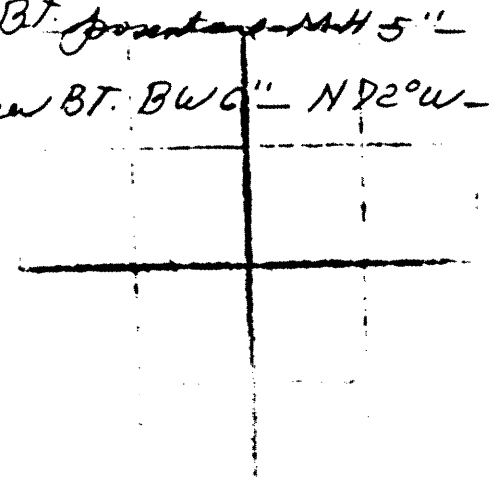
SW 1/4 Sec 2 Set W.C.D. pipe for new 1/4 cor, P 4.049 south of NW cor &  
 40.284 north of SW cor. PW 8" - N 81° W - 0.150; PW 6" - N 62° E - 1.020 ch.  
 Hassler's 1/4 cor is NW 14 1/2 ± ch. (Bennett 1/5/61)  
 See corner file

SW 1/4 SW 1/4 at 20.142 set 1/8 cor. PW 9" - N 88° W - 1.280 ch.; PW 7"  
 N 53° W - 1.20 ch. Hassler's 1/8 is NE 64 ± ch. (Bennett 1/5/61)  
 Set new 1/16 corner N 2° 02' E <sup>47.08'</sup> of Hassler's capped pipe. New BT<sup>s</sup>  
 in swamp. PW 14" S 43° W 90.35'; PW 12" N 54° W 80.90'  
 Seymour, 8/16/84
