SEC. 19 T. 38 N. R. 7 W.

RECEIVED & FILED # 1810
 Onondaga County Surveyor's Office
 Date April 22, 1988
 By J. H.
 DCS Area # B.T.'s - Bw 8" N18W 34;

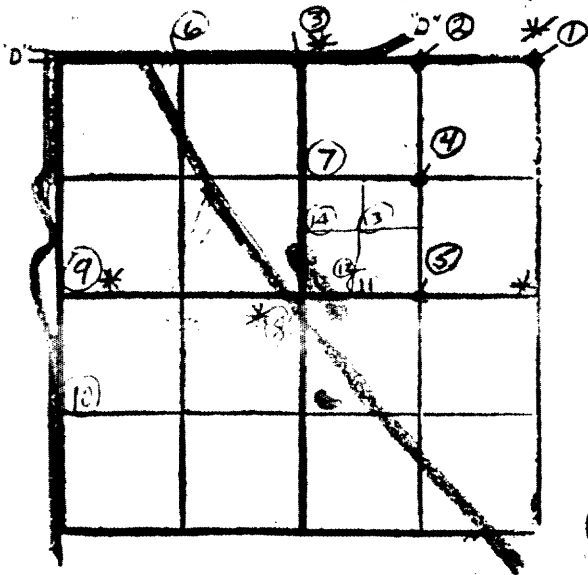
① NE Corner - I.P. Area # B.T.'s - Bw 8" N18W 34;
 Pn stb. 20" N27E 64. (M. Burgy Nat. Cont. Corp.)
 Found 1 1/2" i.p., Bw is fallen over, Pine stp N32°E 41-90',
 New BT^s PN 4" N 8°E 13.72', PN 4" S75°E 27.60', PW 4" S16°E 37.45'
 (12/81 Seymour, Vissers)

② E 1/16 on N line 20.03 ch. E of NE corner.
 I.P. B.T.'s - A 8" N31E 8; Pn stb. 18" N13W 25.
 (M. Burgy Nat. Cont. Corp.) Burgy's cor was
 set in error. Reset with a 1 1/4" i.p. (pulled Burgy pipe out) New BT^s
 Pine stp S27°W 6.84', PW 3" S24°E 6.12', PW 3" S81°W 12.00 to ctr
 (12/81 Seymour + Vissers)

③ N 1/4 W.P. + I.P. 25' N of corner
 Used this pipe to set DNR 2" brass cap (25' S in solar bearing) monument is approx 50' north of E
 BT^s made BW 11" N52°W 15.50', PW 20" N30°E 54.28', PW 16" N69°E 42.38' (12/81 Seymour, Vissers)

④ Corner of NE 1/4 3/4" I.P. B.T.'s - A 5" S 80E 2; A 6" S40W 7. (Berndt, 1956)
 Berndt i.p. is set in error. Reset using 1 1/4" i.p. BT^s Asp 10" S14°W 17.35' (to ctr),
 PW 3" S1°W 36.37', PW 3" N78°E 11.57' (Seymour, Vissers 12/81)

⑤ CE 1/16 At 20.03 ch West of E 1/4, set 3/4" I.P. B.T.'s OR 12" N38E 65.54
 Pw N34W .57 ch. (Berndt, 1956) Berndt i.p. was set in error. Reset using 1 1/4" i.p.
 BT^s OR 12" S63°W 17.23', MH 12" N15°W 7.78', OR 16" N46°E 42.83' (twin), PW 5" N36°W 34.86' (dead)
 (12/81 Seymour, Vissers)

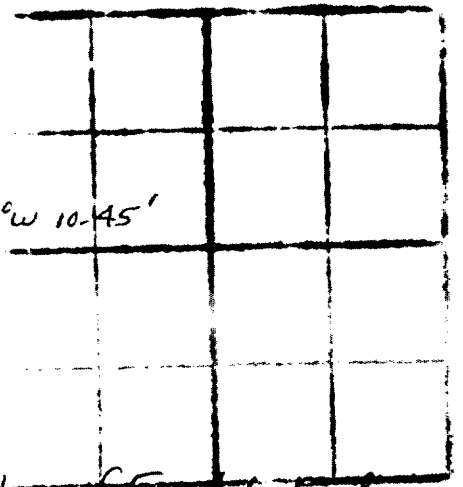
(6) N¹/₄ NW¹/₄ - Found 4" sq wood post marked $\frac{1}{8}$ 25' south

(7) CN¹/₁₆ set 1¹/₄" i.p. 100' \pm east of field edge BT^s BW 4" N 45° W 10.45'
BW 12" S 29° W 45.85' (12/81 Seymour, Vißers)

(8) C¹/₄ 19 set 2" i.p. DNR brass cap on westerly edge blacktop of Fawn Lake Road.
BT^s PW 10" N 8° E 64.11', PW 8" N 72° E 53.53', OR 10" S 13° E 57.40'
(12/81 Seymour, Vißers)

(9) W¹/₄ 19 found Oneida Co. capped 2" Alum. pipe. BT^s Asp 16" N 49° E 10.45', PN 7"
S 28° W 14.60', monument approx 20' east of corner (12/81 Seymour, Vißers)

(10) S¹/₄ set 1¹/₄" i.p. 100' east of field edge BT^s BW 4" N 45° W 10.45'
BW 12" S 29° W 45.85' (12/81 Seymour, Vißers)

(11) W.C. on E/W¹/₄ line east of pond, set 1¹/₄" i.p. BT^s PW 12" S 72° E 24.53', PW 14" N 50° E
13.50', (12/81 Seymour, Vißers)

(12) W.C. north of pond on $\frac{1}{64}$ line, set 1¹/₄" i.p. BT^s BW 7" S 18° E 8.63', BW 7" N 86° E 24.97'
(12/81 Seymour, Vißers)

(13) SW-NE $\frac{1}{64}$ set 1¹/₄" i.p. BT^s BW 24" S 6° E 40.50', PW 4" S 88° E 8.55' (12/81 Seymour, Vißers)

(14) C-S-N $\frac{1}{64}$ set 1¹/₄" i.p. BT^s MR 4" (twin) N 60° W 38.46', CH 6" N 74° E 29.36' (12/81 Seymour, Vißers)

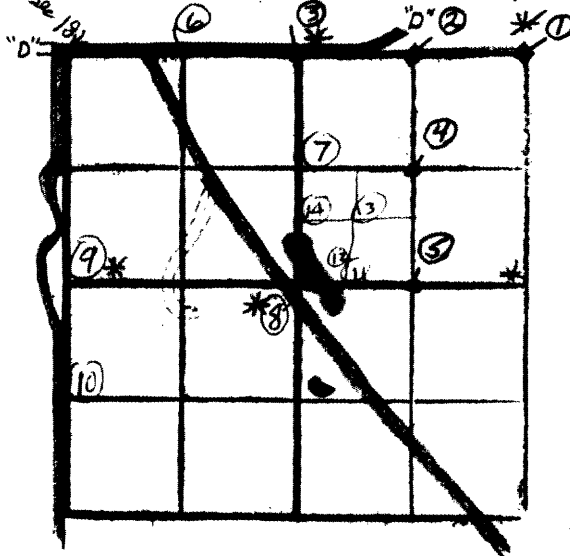
SEC. 19 T. 38 N. R. 7 W.

① NE corner - I.P. B.T.'s - 8w 8" N18W 34';
 Pn stb. 20" N27E 64. (M. Burgy Nat. Cont. Corp.)
 Found 1 1/2" i.p., BW is fallen over, Pine stp N32°E 41-90',
 New BT's PN 4" N 8°E 18-72', PN 4" S 75°E 27-60', PW 4" S 11°W 38.45'
 (12/81 Seymour, Vissers)

② E 1/16 on N line 20.03 ch. E of NE corner.
 I.P. B.T.'s - A 8" N31E 8; Pn stb. 18" N13W 25.
 (M. Burgy Nat. Cont. Corp.) Burgy's cor was
 set in error. Reset with a 1 1/4" i.p. (pulled Burgy pipe out) New BT's
 Pine stp S 27°W 6.84', PW 3" S 24°E 6-12', PW 3" S 81°W 12.00 to ctr
 (12/81 Seymour + Vissers)

③ N 1/4 W.P. + I.P. 25' N of corner
 Used this pipe to set DNR 2" brass cap (25's br i.p. solar bearing) monument is approx 50' north E
 BT's made BW 11" N 52°W 15.50', PW 20" N 30°E 54.28', PW 16" N 69°E 42.38' (12/81 Seymour, Vissers)
 (this may or may not be right)

④ Center of NE 1/4 3/4" I.P. B.T.'s - A 5" S 80°E 2; A 6" S 40°W 7. (Berndt, 1956)
 Berndt i.p. is set in error. Reset using 1 1/4" i.p. BT's Asp 10" S 14°W 17.35' (to ctr),
 PW 3" S 1°W 36.37', PW 3" N 78°E 11.57' (Seymour, Vissers 12/81)

⑤ CE 1/16 At 20.03 ch West of E 1/4, set 3/4" I.P. B.T.'s 0-12" N 38°E .65 ch
 Pw N 34°W .57 ch. (Berndt, 1956) Berndt i.p. was set in error. Reset using 1 1/4" i.p.
 BT's OR 12" S 63°W 17.23', MH 12" N 15°W 7.78', OR 16" N 46°E 42.83' (twin), Pw 5" N 36°W 34.86' (dead)
 (12/81 Seymour, Vissers)

(12/81 Seymour, Vissers) BT's OR 12" S 63°W 17.23', MH 12" N 15°W 7.78', OR 16" N 46°E 42.83' (twin), Pw 5" N 36°W 34.86' (dead) (12/81 Seymour, Vissers)

⑥ N¹/₄ NW¹/₄ - Found 4" sq wood post marked $\frac{1}{8}$ 25' south
(prob. is wrong)

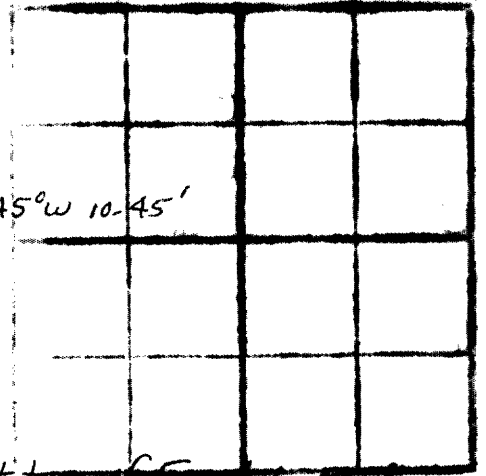
⑦ CN¹/₁₆ set 1¹/₄" i.p. 100' ± east of field edge BT^S BW 4" N 45° W 10.45'
BW 12" S 29° W 45.85' (12/81 Seymour, Vißers)

⑧ C¹/₄ 19 set 2" i.p. DNR brass cap on westerly edge black top of Fawn Lake Road.
BT^S PW 10" N 8° E 64.11', PW 8" N 72° E 53.53', OR 10" S 13° E 57.40'
(12/81 Seymour, Vißers)

⑨ W¹/₄ 19 Found Oneida Co. capped 2" Alum. pipe. BT^S Asp 10" N 49° E 10.95', PN 7"
S 28° W 14.60', mon. is approx 250' east of Lakewood Rd, (12/81 Seymour, Vißers)
