U.S. PUBLIC LAND SURVEY MONUMENT LOCATION RECORD

CORNER: North 1/4 SECTION: 12 TOWNSHIP 36 NORTH RANGE 6 EAST/WEST

(CITY)(VILLAGE)(TOWN) OF: Nokomis COUNTY OF: Oneida

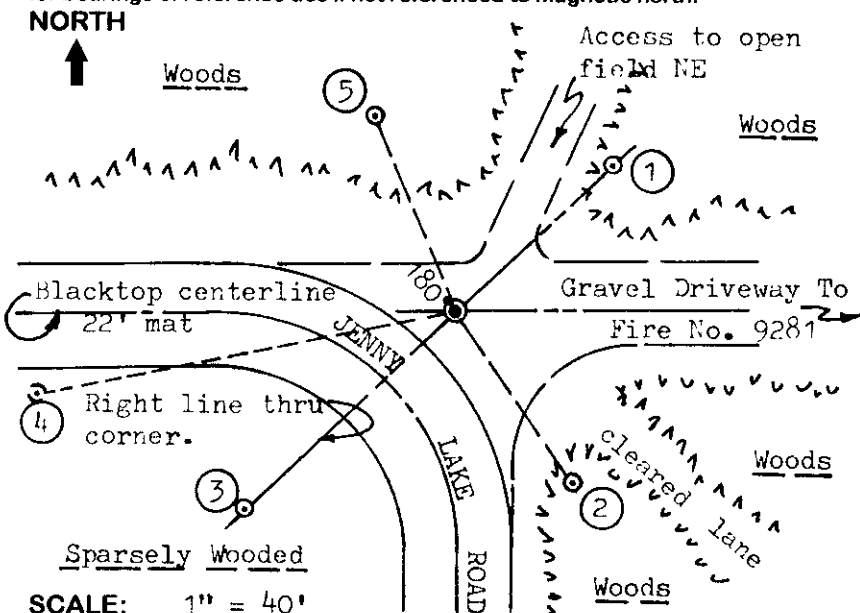
Plan view map of monument location with bearing and distance ties to a minimum of four (4) described witness or reference monuments of concrete, natural stone, iron, live bearing trees or equivalent material. If applicable, also show a minimum of two (2) bearing and distance ties to any other monument found and not accepted; including the bearing and distance from the accepted monument. Indicate the basis for bearings of reference ties if not referenced to magnetic north.

- ① 1" dia. by 24" long iron pipe set with standard Reference Mark cap in top flush to grade and 1.2' East of 8" Pr center, N47°E 44.55'.
- ② New BT 10" Pr S34°E 43.08'.
- ③ 1" dia. by 24" long iron pipe set with standard Reference Mark cap in top flush to grade, S47°W at 60.79'.
- ④ Old BT by Wis DOT, now 14" Pj with no markings visible, S79°W 89' +/-.
- ⑤ New BT 7 1/2" Pj N22°W 44.20' with BT sign nailed to South face.

Note: Standard white poly 'T' marker post set 6" SW of Witness No. 3.

Unless otherwise indicated, all bearing tree ties are to a .25" dia. by 2.5" long PK nail with a 1.25" dia. steel washer driven into unblazed right face and a .25" dia. by 2.5" long PK nail with a 2" dia. steel washer stamped 'BT' is also driven into unblazed face of bearing tree at DBH; the basis for measured bearings is magnetic to nearest degree and all tie distances are horizontal measure to nearest 1/100th feet.
