U.S. PUBLIC LAND SURVEY MONUMENT RECORD

Oneida County
Land Information Office
Filed
1/23/2024

(a) CORNER LOCATION: WISCRS - Oneida County
 Northeast corner of Section 2 North: 197,703.35 USft
 Township 37 North East: 318861.28 USft
 Range 10 East Datum: NAD 83(2011) ep. 2010.00
 Town of Stella GNSS Method: RTN - Direct
 County of Oneida GNSS Control: WISCORS VRS

INDEX NO. A - 21
 3810350000

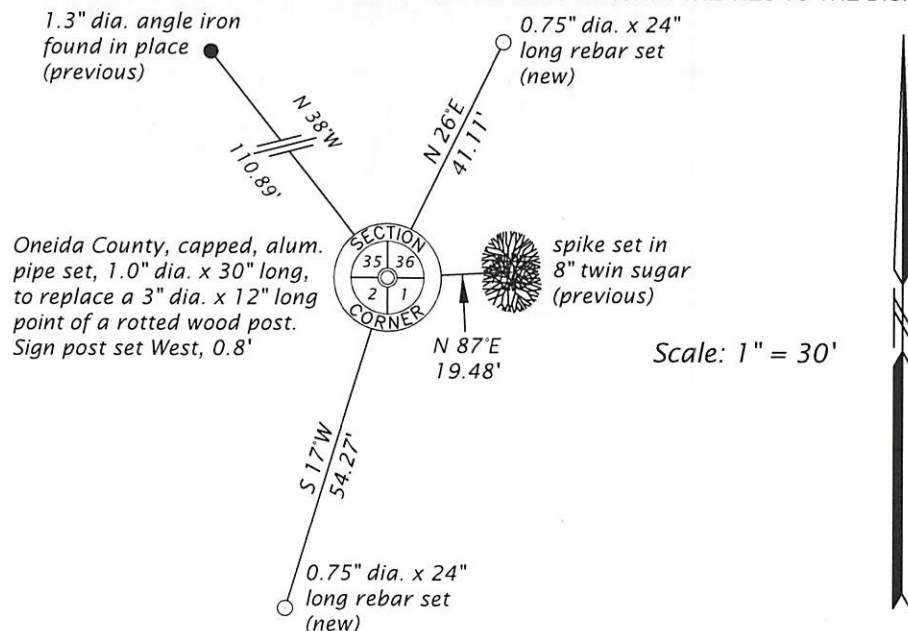
(c)(d)(e) PLAN VIEW OF CORNER WITH TIES TO AT LEAST 4 WITNESS MONUMENTS. IF IN DISAGREEMENT WITH PREVIOUSLY ESTABLISHED CORNER, SHOW THE DISTANCE BETWEEN THE TWO CORNERS AND ALSO INDICATE THE TIES TO THE DISPUTED CORNER.

November 27, 2023 - James D. Rein, PLS No. 1234, scalping ground 8 inches deep, we recovered 3" dia. x 12" long wood post point, and old orange ribbon with blue paint under duff. At post point we set a 1" dia. x 30" long capped stamped aluminum monument. A birch stump with a distinct seam bears N77°W, 22.4 feet and deep stump hole, possible D.H. Vaughan hemlock bears S61°E, 22.5 feet. This corner position is harmonious with Vaughans measurement 39.73 chains (2622.18) versus ours 2619.30 feet to the quarter corner common to Sections 1 and 2. A 1.3" angle iron, apparently accepted for timber cutting purposes, bears N38°W, 110.89 feet. We set a white sign post 0.8 feet west of the corner and made additional reference ties as shown in plan.

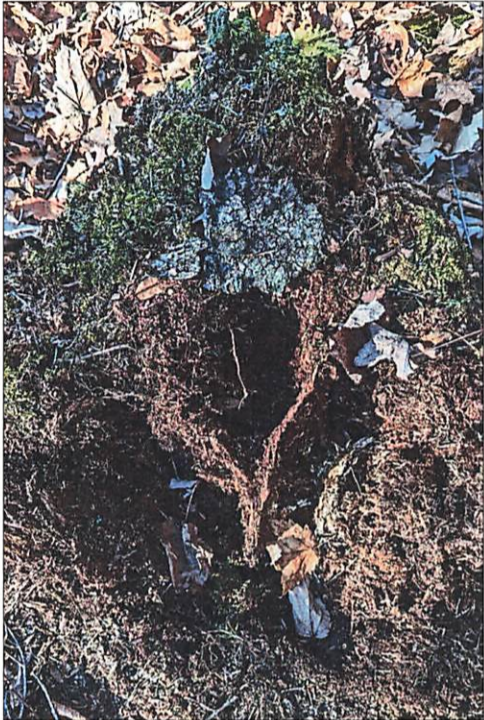
Photo of Ray H. Hall BT

birch tree stump

October 12, 1936 - Ray H. Hall, CCC Camp 75-S Minocqua, CCC Book 6, page 44 Identified by old post agreeing with orig. NW brng. still standing, by D.H.V. Hemlock (1909) down. On north slope. Set new 5"x5" Cedar post and bts: W. Birch 7" N76°W, .334 ch. (22.04'); W. Birch 8" N3 1/2°E, .463 ch. (30.56'); W. Birch, 5" S33°W, .57 ch. (37.62'); Y. Birch 3" S32°E, .395 ch. (26.07').

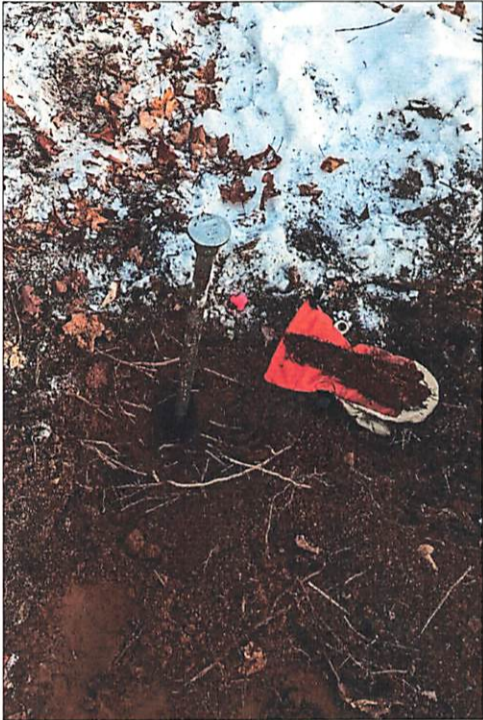
Photo of Site

new monument in found hole

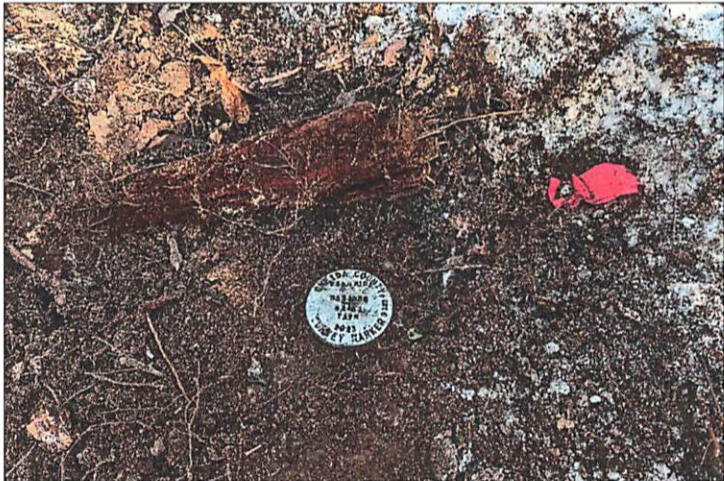
Photo of Site

rotted wood post point & new monument
