U.S. PUBLIC LAND SURVEY MONUMENT RECORD

(a) CORNER LOCATION: South Line
West Meander Corner of Section 33
Township 40 North, Range 11 East
Township/City VILAS/ONEIDA
County of Washington

VILAS COUNTY GPS OBSERVATION RECORD

Corner ID: 4011330018 Sec 33, T40N, R11E

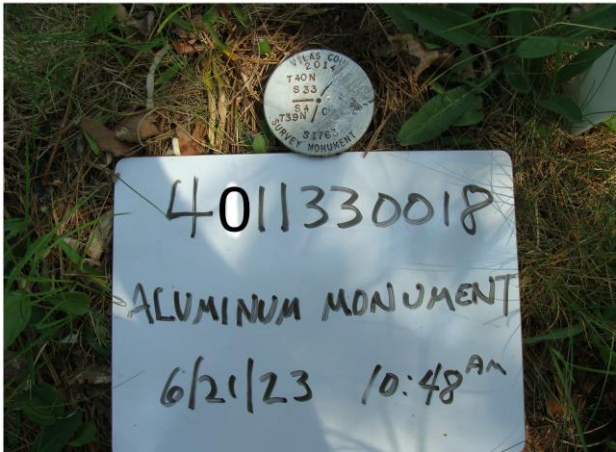
Monument Photo

FOUND ALUMINUM MONUMENT IN GOOD CONDITION AS DESCRIBED. SEE USPLSS MONUMENT RECORD FOR MORE INFORMATION.
