Part of
 GOVERNMENT LOT 9, SECTION 14 and
 part of the
 NORTHEAST 1/4 of the NORTHEAST 1/4, SECTION 23
 TOWNSHIP 39 NORTH, RANGE 6 EAST
 Town of Minocqua
 Oneida County, Wisconsin

REVISED: June 28, 2019
 Added impervious surfaces
 New boathouse
 Job No. 219030
 Field survey worked complete on
 June 28, 2019

DRAFTED BY: Benton A. McMullen	DATE: September 6, 2017
SCALE: 1" = 50'	JOB NBR: 217040
SHEET 1 OF 1 SHEETS

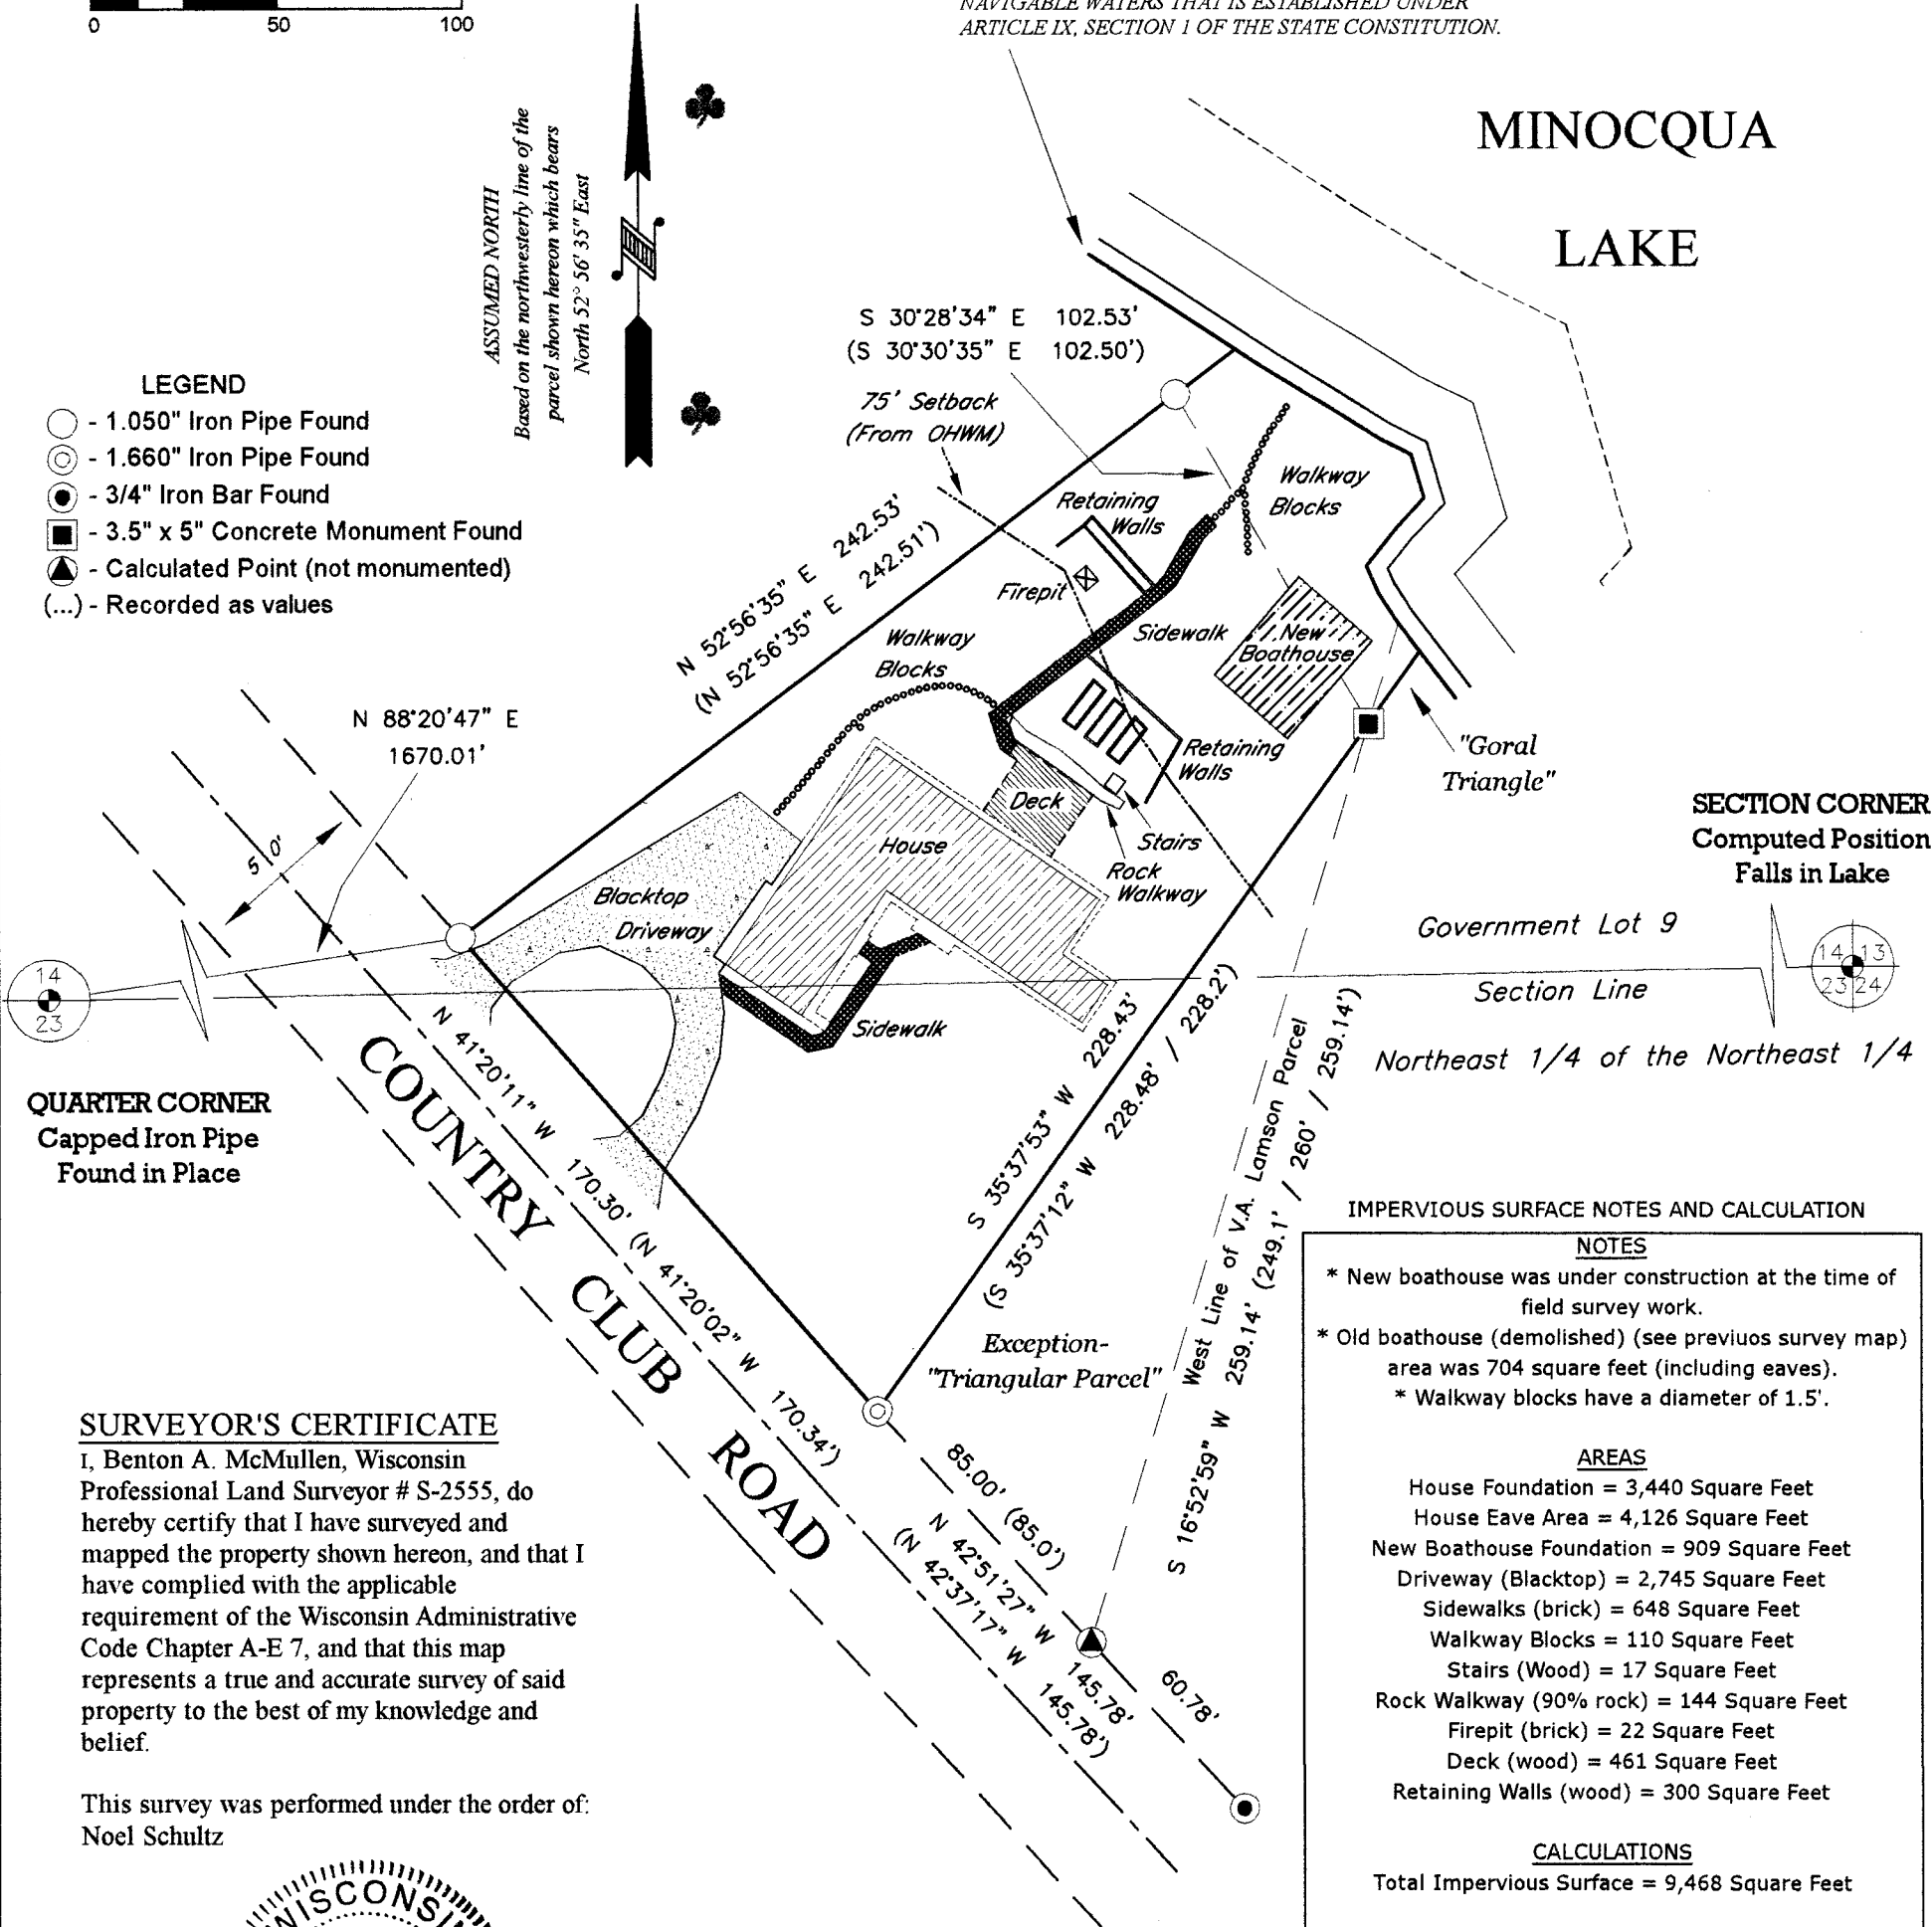
MINOCQUA
 LAKE

ASSUMED NORTH
 Based on the northwesterly line of the
 parcel shown hereon which bears
 North 52° 56' 35" East

- * New boathouse was under construction at the time of field survey work.
- * Old boathouse (demolished) (see previous survey map) area was 704 square feet (including eaves).
- * Walkway blocks have a diameter of 1.5'.

- House Foundation = 3,440 Square Feet
- House Eave Area = 4,126 Square Feet
- New Boathouse Foundation = 909 Square Feet
- Driveway (Blacktop) = 2,745 Square Feet
- Sidewalks (brick) = 648 Square Feet
- Walkway Blocks = 110 Square Feet
- Stairs (Wood) = 17 Square Feet
- Rock Walkway (90% rock) = 144 Square Feet
- Firepit (brick) = 22 Square Feet
- Deck (wood) = 461 Square Feet
- Retaining Walls (wood) = 300 Square Feet

- Total Impervious Surface = 9,468 Square Feet
- Total Lot Area = 34,324 Square Feet
- Percent of Impervious Surface = 28%
