MAP # A3734 ✓  
 DATE FILED 3/1/2021  
 BY JAP  
 DESCRIPTION  
 ONEIDA CO. SURVEYOR'S OFFICE

**MAINES & ASSOCIATES**  
 Land Surveyors  
 Arbor Vitae, WI 54568  
 Phone 715.356.9485  
 Eagle River, WI 54521  
 Phone 715.479.2570  
 mainesandassociates.com

**Lot 3 of Certified Survey Map 4923**  
 Being part of Government Lot 3, Section 12 and part of the NE 1/4 of the SE 1/4 and Government 2, Section 11 all in T 38 N, R 9 E, Town of Sugar Camp, Oneida County, Wisconsin

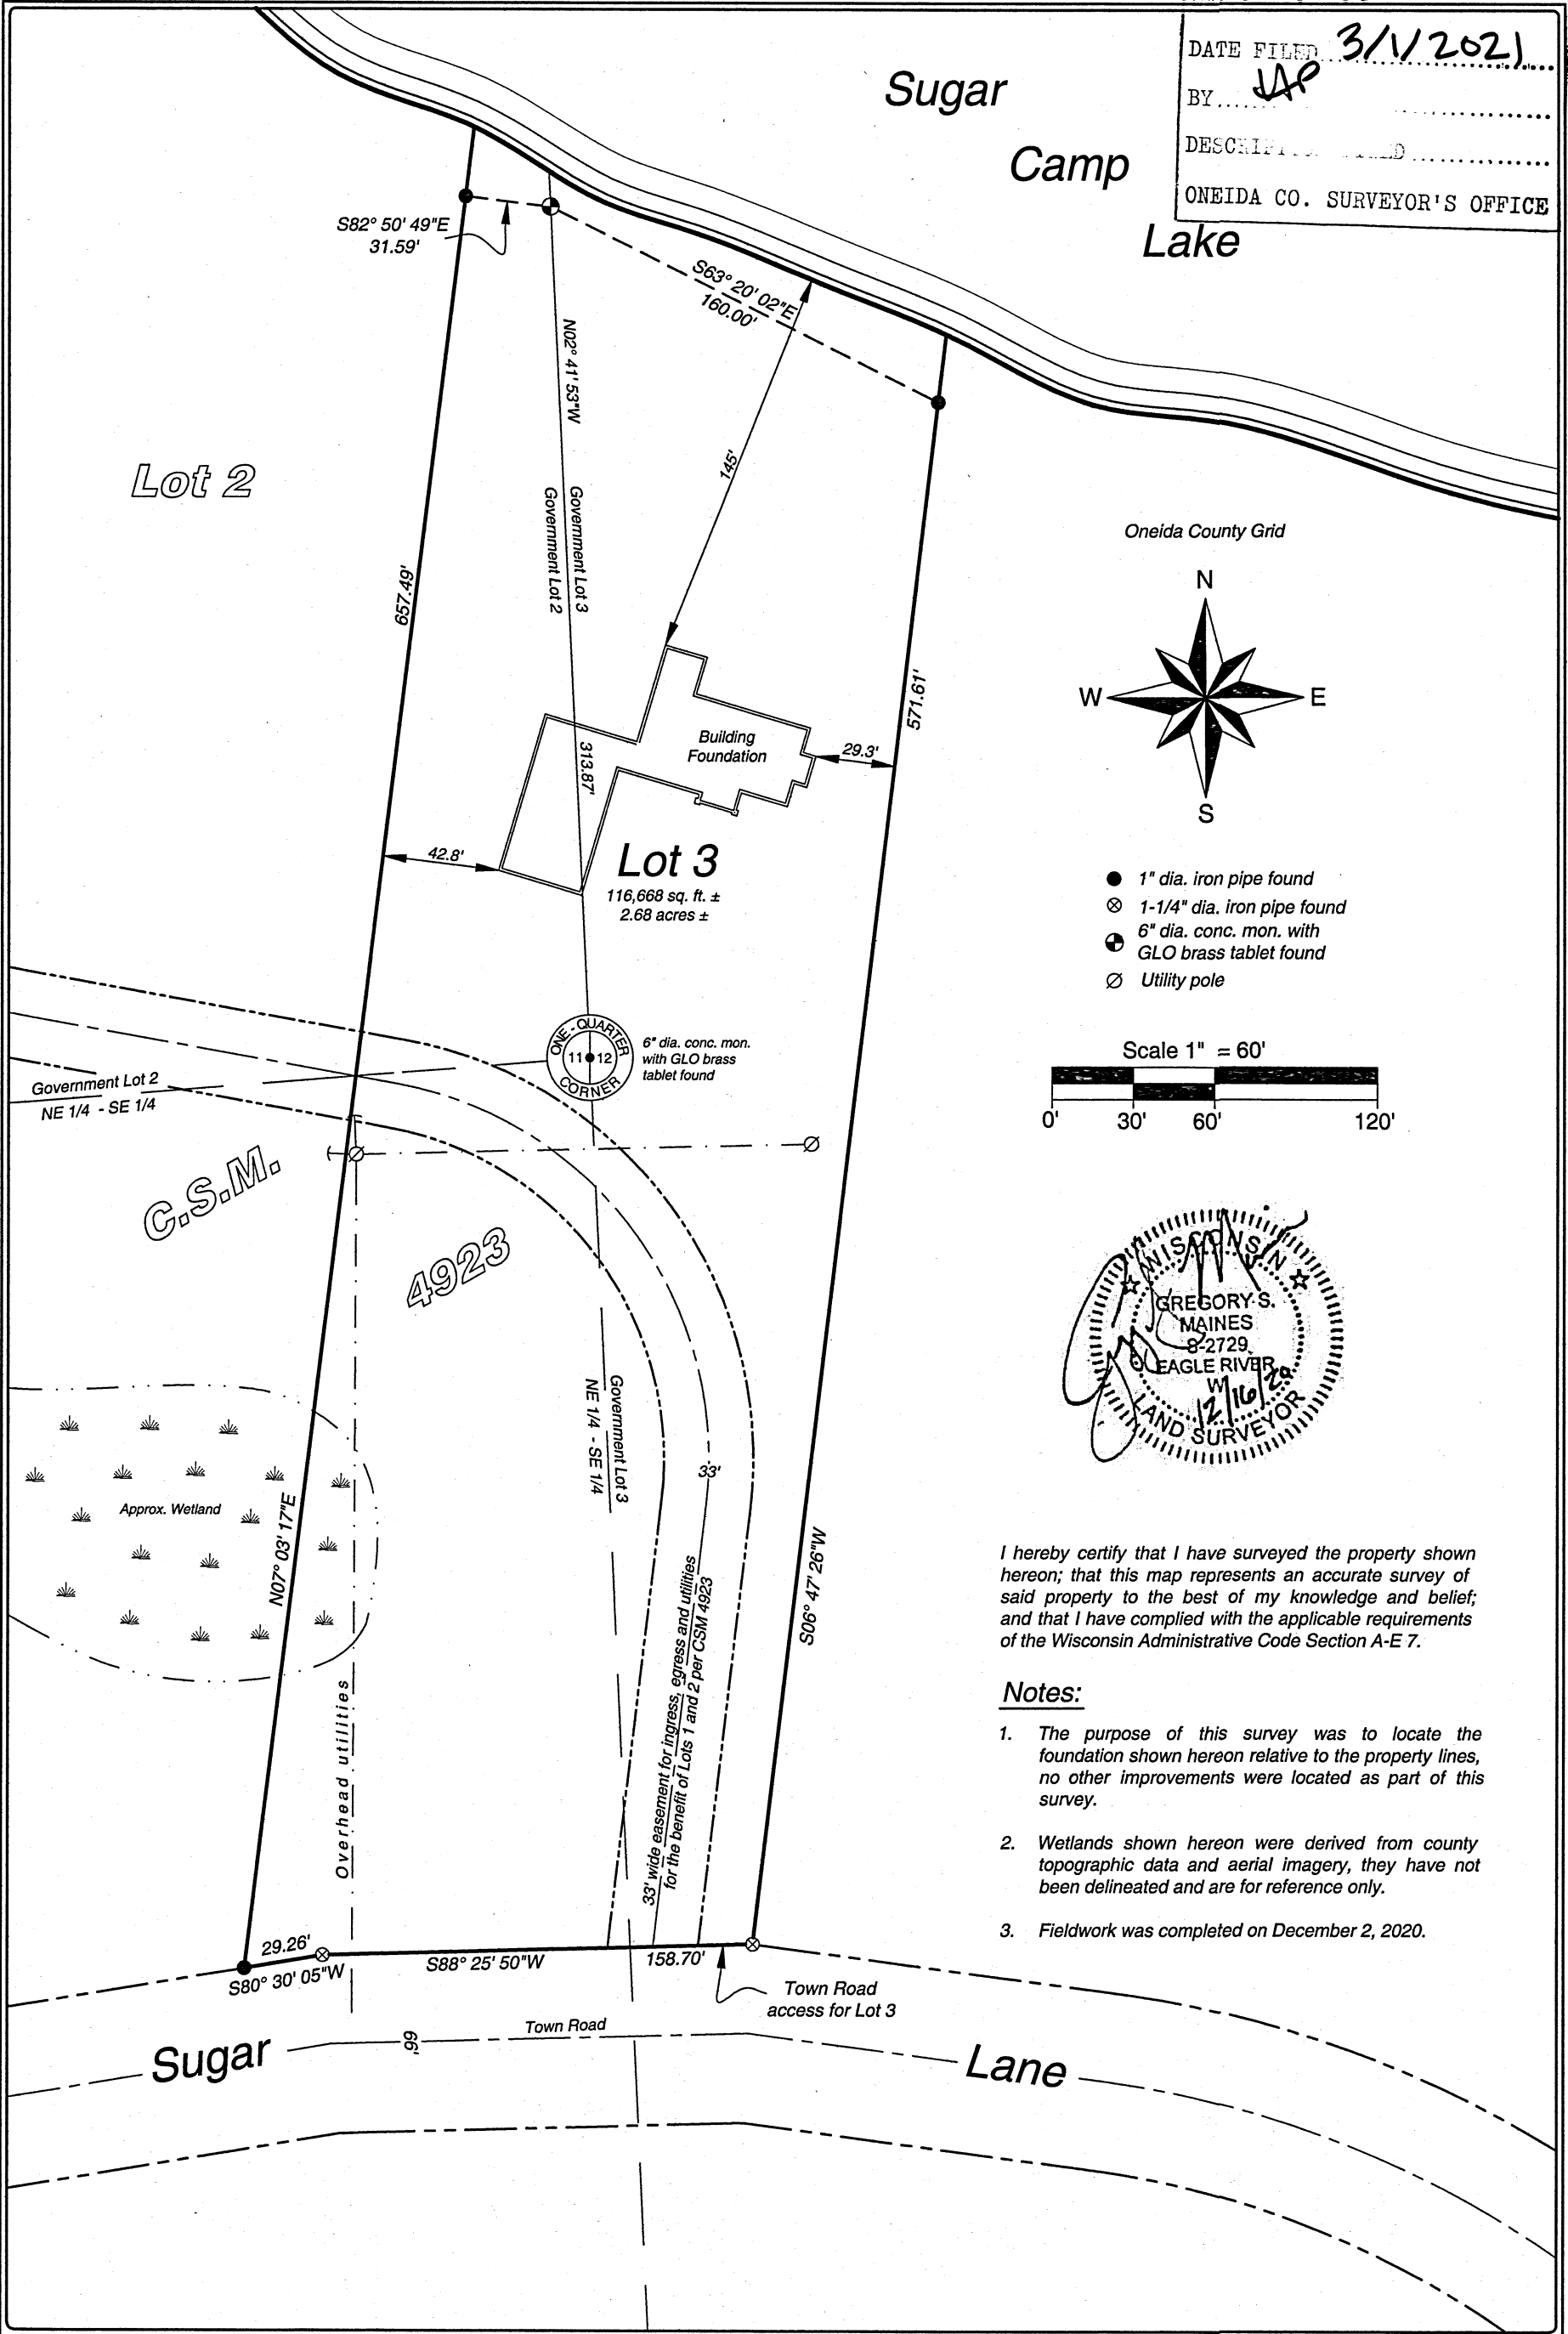
1. The purpose of this survey was to locate the foundation shown hereon relative to the property lines, no other improvements were located as part of this survey.
2. Wetlands shown hereon were derived from county topographic data and aerial imagery, they have not been delineated and are for reference only.
3. Fieldwork was completed on December 2, 2020.
